Safeguard
Properties

Assessing Structural Damages

Identifying Structural Damage (ext. and foundation)

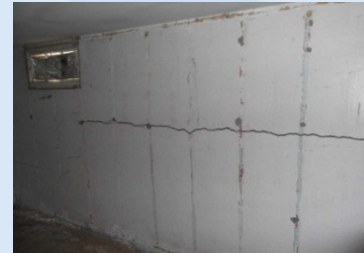
Horizontal Crack

Horizontal cracks (also called buckling cracks) are serious and need to be addressed immediately. These cracks will run along extensive lengths of a foundation wall and be more or less horizontal.

Horizontal cracks

The cause here is a foundation wall that is about to collapse inward from excessive pressure from the outside. To deal with this type of cracking the interior wall needs to be buttressed (braced) and then the exterior of the wall excavated to relieve the pressure on the wall. Permanent repairs vary according to the situation, but generally the wall needs to be pushed back into place and additional concrete buttressing columns and/or steel strapping need to be poured in place/installed on the inside of the existing wall. This work should be completed by a company specializing in this type of repair.

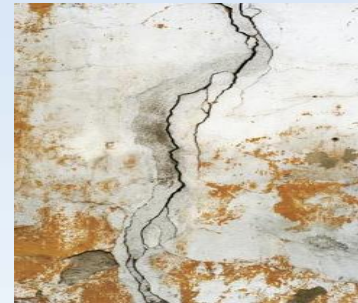
Rotational Crack

Rotational cracks (also called settling cracks) are caused by one section of a foundation settling while another section is stable. This causes the settling section to "rotate" away from the stable section, as if the bottom of the wall is on a hinge. The cracking will be V shaped from bottom to top with the top of the crack wider than the bottom. This condition will continue to worsen unless correctly dealt with.

Rotational cracks

Patching the crack will fail as the crack will continue to grow in width. The settling section of the foundation needs to be buttressed by concrete or steel column(s) or piers from the exterior. Then the crack can be repaired from the exterior in the same manner as a vertical crack (see above). The columns or piers should be completed by a company specializing in this type of repair.

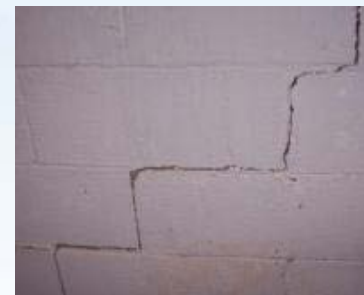
Step Crack

Step cracks when inspecting a block or stone foundation the cracking involved will usually follow the mortar joints and is called step cracking due to the cracking pattern. Otherwise the cracks will be similar in appearance and pattern to foundation cracks in all other respects.

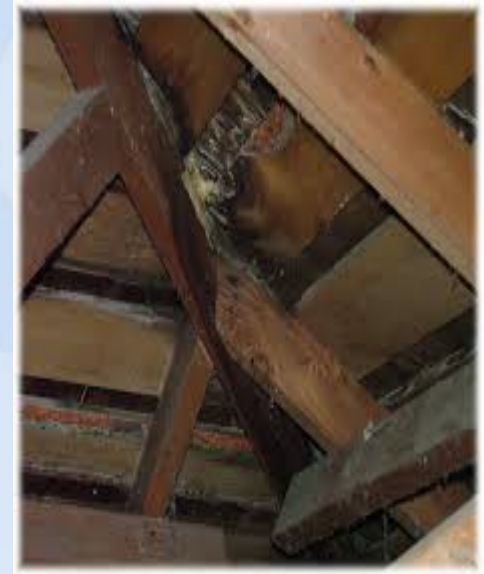
Attic Water Damage

Water staining, wood that is rotting on the underside of the sheeting or on the rafters, and light coming through the underside of the roof.

If wood rot is suspected, use a screw driver or pen to push into the affected area. If area is soft, then the wood is likely rotted and needs to be addressed by removal and replacement of that area.

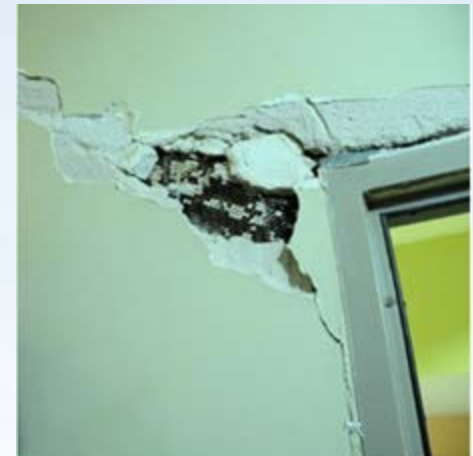
Deep cracking in door frame

Bulges, leaning walls, deep cracks in drywall/plaster (especially around door frames), windows/doors that do not close properly or line up incorrectly, sagging/uneven ceilings, cracks in the ceiling and uneven/rolling floors.

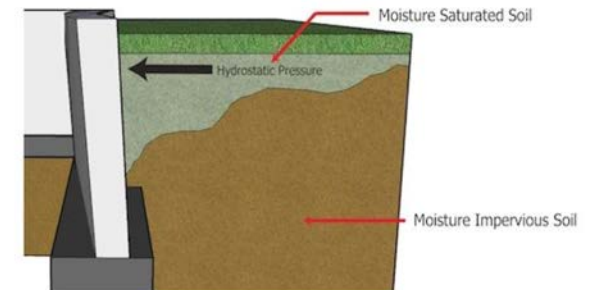
Leaning Wall

Foundation Cracks:
Lateral Movement - Side View
Vertical Cracking

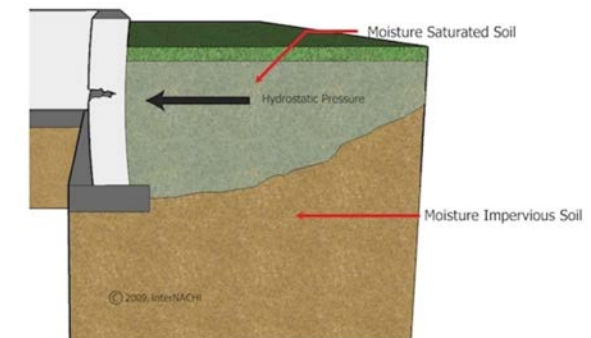
Buckling Wall

Foundation Cracks:
Lateral Movement - Side View
Horizontal Cracking

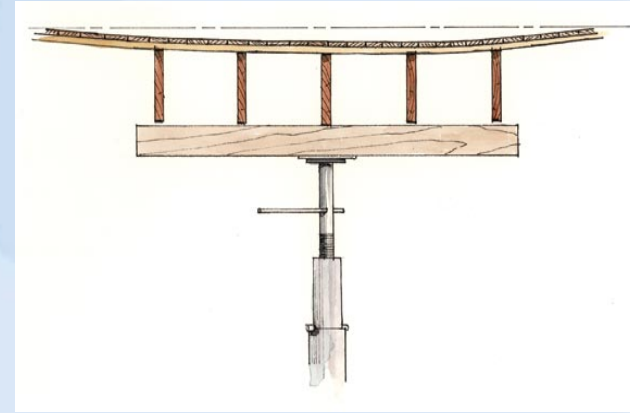
Raising a Floor

If wood support beam (micro-lam or joined dimensional lumber) is cracked, the floor system needs to be jacked up to slightly above the correct height. Then the beam needs to be repaired or replaced as needed. Commonly a beam repair is accomplished by adding additional lumber (micro-lam or dimensional) alongside the damaged area with the repair lumber spanning from support structure to support structure and correctly attached to the damaged beam. It is often necessary to add a support column underneath the damaged area. In this case the concrete floor needs to be cut away and an adequate footing poured underneath the column, the column set in place, and new concrete flooring poured to fill in the removed area of the floor. When all repairs are complete the floor system is lowered on to the repaired beam.

If a support beam is tilted, it is necessary to return the beam to a plumb (vertical) position. Ensure that the floor system is jacked up to slightly above the correct height, the beam is adjusted to the correct position and the floor lowered onto the corrected beam. It is always necessary to address the underlying cause of the beam issue to ensure that the beam does not tip again. This is often accomplished with blocking or bracing of the beam.

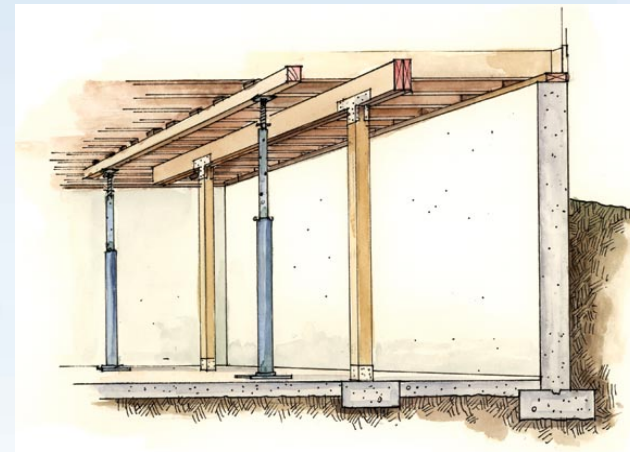
Temporary Bracing

If an interior header is damaged or missing, the drywall or stucco covering the header needs to be removed. The ceiling structure in the affected area needs to be temporarily braced, then any damaged structure removed. New, correctly sized and assembled header and/or support posts are put in place. The temporary bracing is removed and the affected area is dry walled or stucco is applied as needed. Mudding, sanding, painting and trimming of the area are the finishing steps in the process.

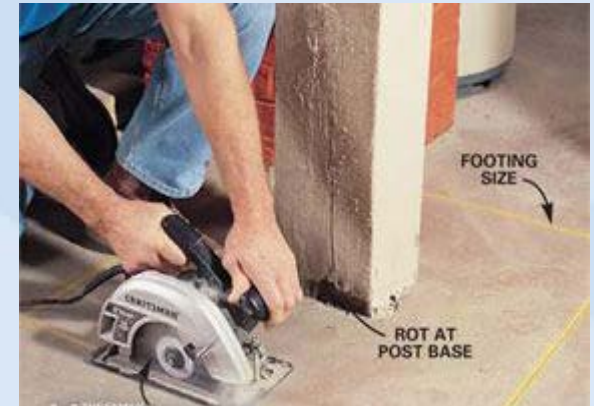
Cutting Concrete

If the floor below a column is cracked around the perimeter of the base of the column and the floor inside the perimeter of the cracking is lower than the surrounding floor, it is an indication of a failing footing underneath the column. In this case the affected area of flooring above the column needs to be jacked up slightly above the correct height, the affected concrete flooring at the base of the column cut and removed and the column taken out. The failed footing underneath the removed concrete is removed and the fill underneath the footing is inspected for possible issues. Any substrate issue below the footing needs to be addressed. A correct footing base is prepared; then a new, adequate footing is poured and the column is then set in place. The flooring above is lowered into place.

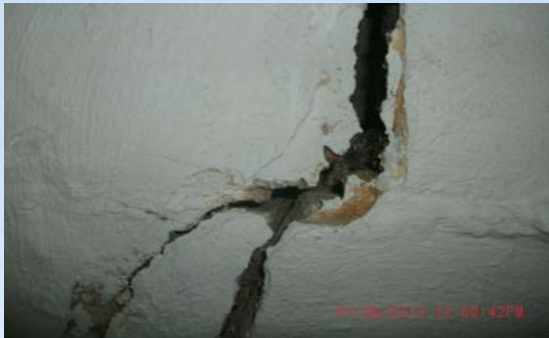
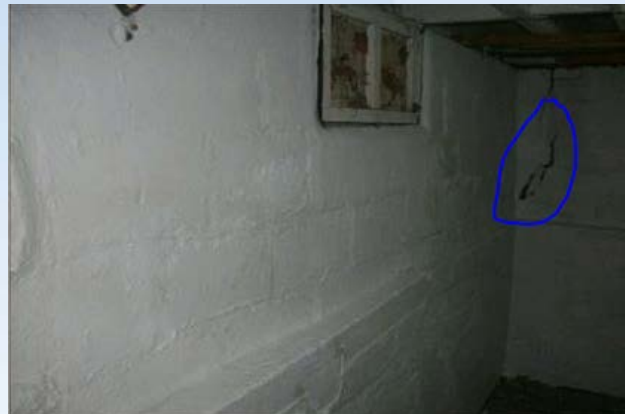
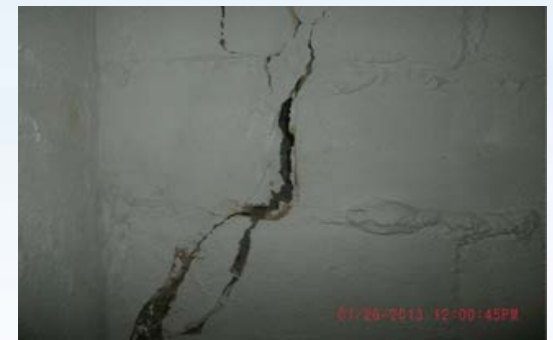
06/19/12 Dry locked basement, filled cracks, photos show some cracks still present after epoxy and dry lock

The repair to the cracks was temporary and did not resolve the underlying issue; therefore, the basement wall continued to crack.

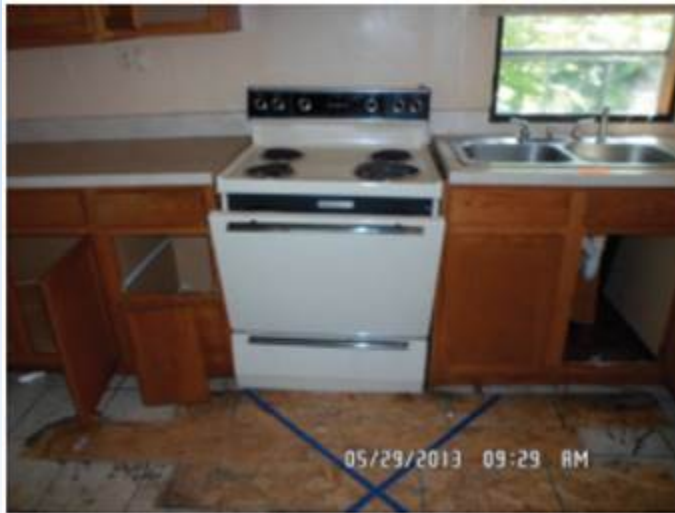
Appliances fallen through rotten floor

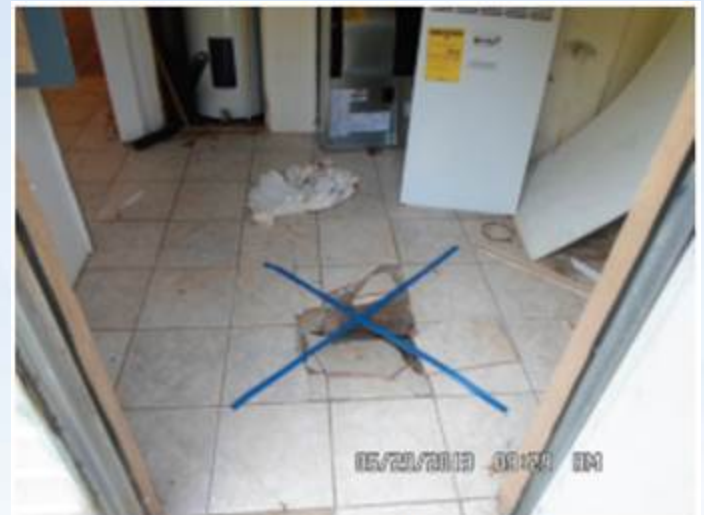
Rotten floor in utility room
