**Safeguard**  
Properties

# Assessing Structural Damages

## Identifying Structural Damage (ext. and foundation)

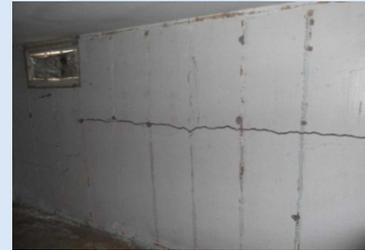
### Horizontal Crack

**Horizontal cracks** (also called buckling cracks) are serious and need to be addressed immediately. These cracks will run along extensive lengths of a foundation wall and be more or less horizontal.

## Horizontal cracks

The cause here is a foundation wall that is about to collapse inward from excessive pressure from the outside. To deal with this type of cracking the interior wall needs to be buttressed (braced) and then the exterior of the wall excavated to relieve the pressure on the wall. Permanent repairs vary according to the situation, but generally the wall needs to be pushed back into place and additional concrete buttressing columns and/or steel strapping need to be poured in place/installed on the inside of the existing wall. This work should be completed by a company specializing in this type of repair.

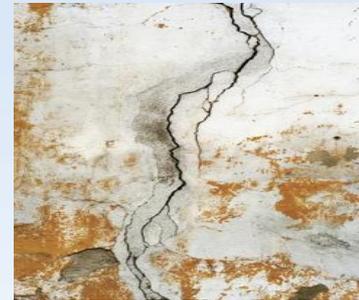
### Rotational Crack

**Rotational cracks** (also called settling cracks) are caused by one section of a foundation settling while another section is stable. This causes the settling section to "rotate" away from the stable section, as if the bottom of the wall is on a hinge. The cracking will be V shaped from bottom to top with the top of the crack wider than the bottom. This condition will continue to worsen unless correctly dealt with.

## Rotational cracks

Patching the crack will fail as the crack will continue to grow in width. The settling section of the foundation needs to be buttressed by concrete or steel column(s) or piers from the exterior. Then the crack can be repaired from the exterior in the same manner as a vertical crack (see above). The columns or piers should be completed by a company specializing in this type of repair.

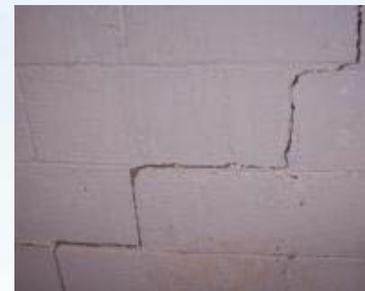
### Step Crack

**Step cracks** when inspecting a block or stone foundation the cracking involved will usually follow the mortar joints and is called step cracking due to the cracking pattern. Otherwise the cracks will be similar in appearance and pattern to foundation cracks in all other respects.

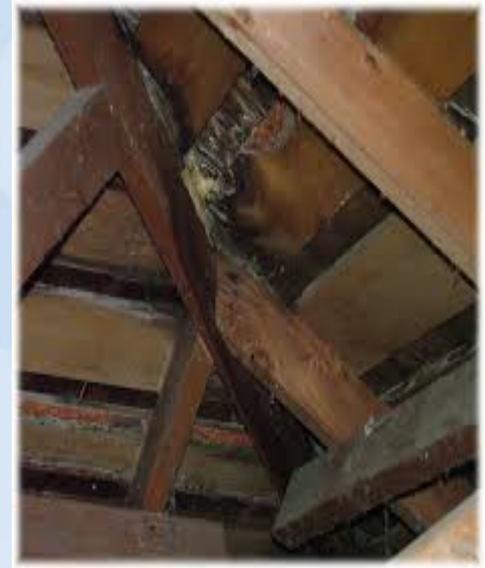
### Attic Water Damage

Water staining, wood that is rotting on the underside of the sheeting or on the rafters, and light coming through the underside of the roof.

If wood rot is suspected, use a screw driver or pen to push into the affected area. If area is soft, then the wood is likely rotted and needs to be addressed by removal and replacement of that area.

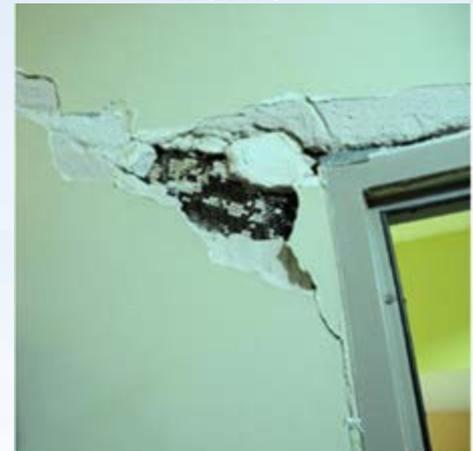
### Deep cracking in door frame

Bulges, leaning walls, deep cracks in drywall/plaster (especially around door frames), windows/doors that do not close properly or line up incorrectly, sagging/uneven ceilings, cracks in the ceiling and uneven/rolling floors.

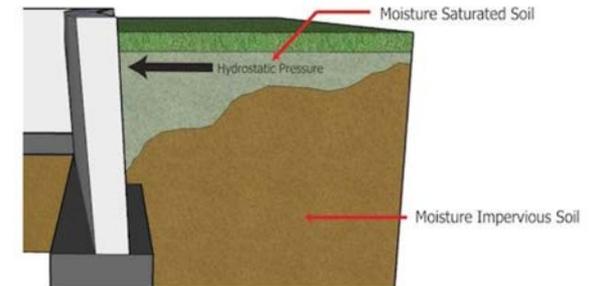
## Leaning Wall

Foundation Cracks:  
Lateral Movement - Side View  
Vertical Cracking

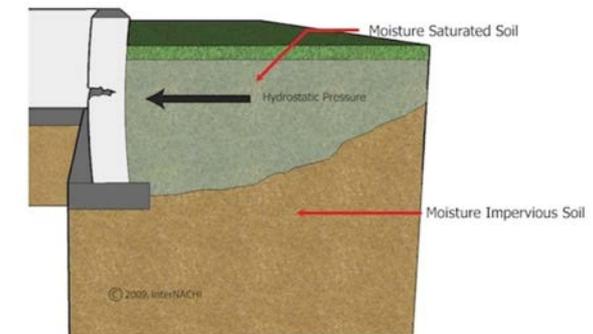
## Buckling Wall

Foundation Cracks:  
Lateral Movement - Side View  
Horizontal Cracking

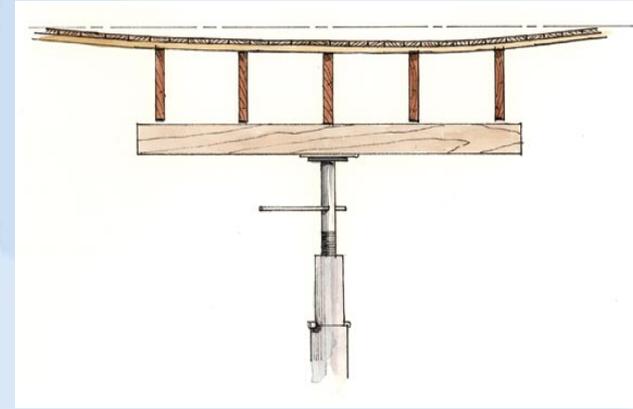
## Raising a Floor

If a support beam is tilted, it is necessary to return the beam to a plumb (vertical) position. Ensure that the floor system is jacked up to slightly above the correct height, the beam is adjusted to the correct position and the floor lowered onto the corrected beam. It is always necessary to address the underlying cause of the beam issue to ensure that the beam does not tip again. This is often accomplished with blocking or bracing of the beam.

If wood support beam (micro-lam or joined dimensional lumber) is cracked, the floor system needs to be jacked up to slightly above the correct height. Then the beam needs to be repaired or replaced as needed. Commonly a beam repair is accomplished by adding additional lumber (micro-lam or dimensional) alongside the damaged area with the repair lumber spanning from support structure to support structure and correctly attached to the damaged beam. It is often necessary to add a support column underneath the damaged area. In this case the concrete floor needs to be cut away and an adequate footing poured underneath the column, the column set in place, and new concrete flooring poured to fill in the removed area of the floor. When all repairs are complete the floor system is lowered on to the repaired beam.

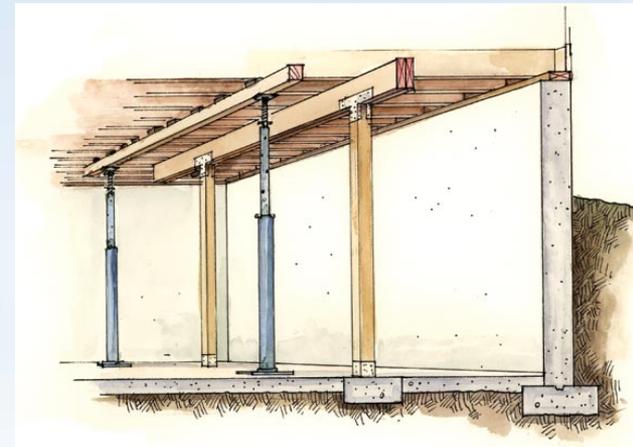
## Temporary Bracing

If an interior header is damaged or missing, the drywall or stucco covering the header needs to be removed. The ceiling structure in the affected area needs to be temporarily braced, then any damaged structure removed. New, correctly sized and assembled header and/or support posts are put in place. The temporary bracing is removed and the affected area is dry walled or stucco is applied as needed. Mudding, sanding, painting and trimming of the area are the finishing steps in the process.

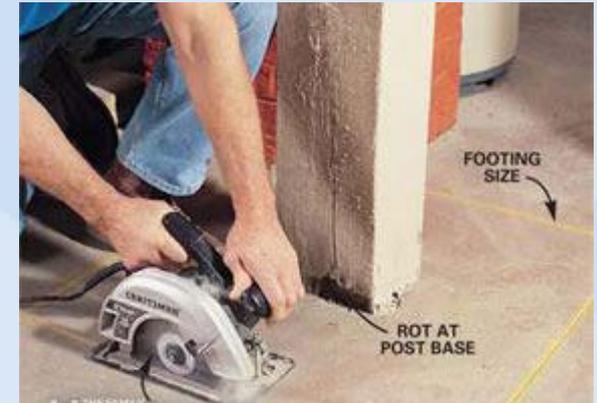
## Cutting Concrete

If the floor below a column is cracked around the perimeter of the base of the column and the floor inside the perimeter of the cracking is lower than the surrounding floor, it is an indication of a failing footing underneath the column. In this case the affected area of flooring above the column needs to be jacked up slightly above the correct height, the affected concrete flooring at the base of the column cut and removed and the column taken out. The failed footing underneath the removed concrete is removed and the fill underneath the footing is inspected for possible issues. Any substrate issue below the footing needs to be addressed. A correct footing base is prepared; then a new, adequate footing is poured and the column is then set in place. The flooring above is lowered into place.

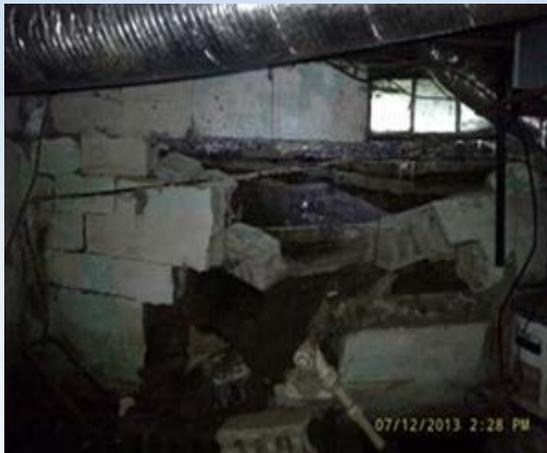
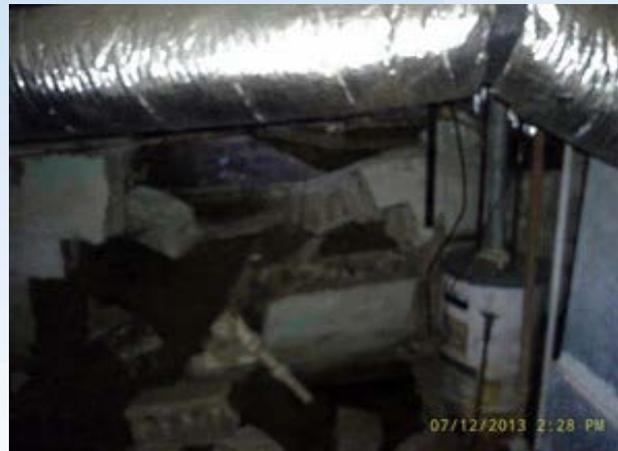
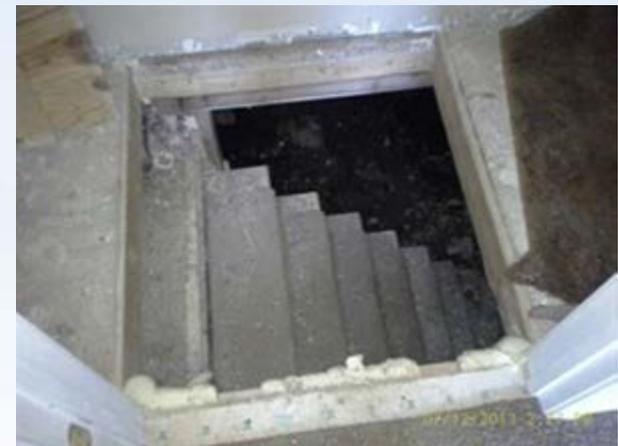
This property was conveyed to HUD with a front foundation that was crumbling and collapsing due to structural damages in the basement. The basement was filled with water, debris and safety issues. The building commissioner inspected the property, found it to be structurally unsound and deemed it uninhabitable.

Vendor failed to report there was a basement present.

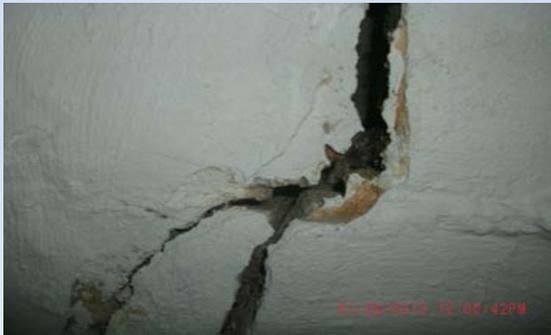
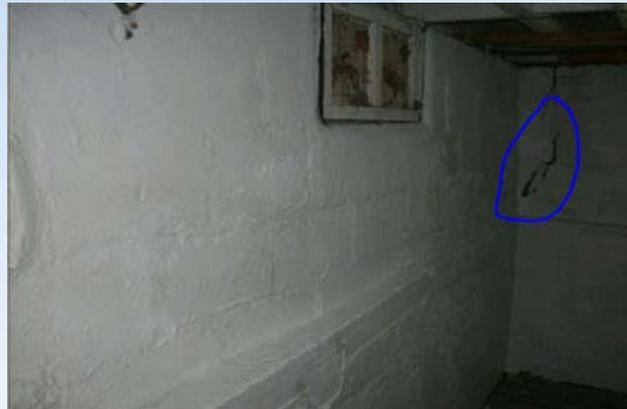
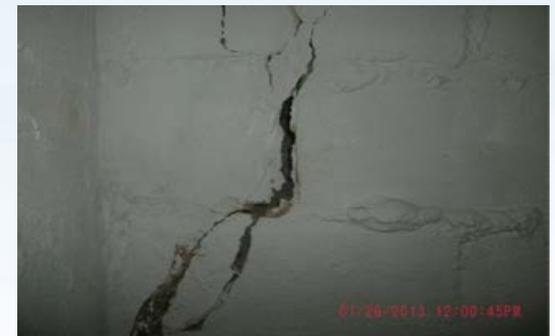
06/19/12 Dry locked basement, filled cracks, photos show some cracks still present after epoxy and dry lock

The repair to the cracks was temporary and did not resolve the underlying issue; therefore, the basement wall continued to crack.

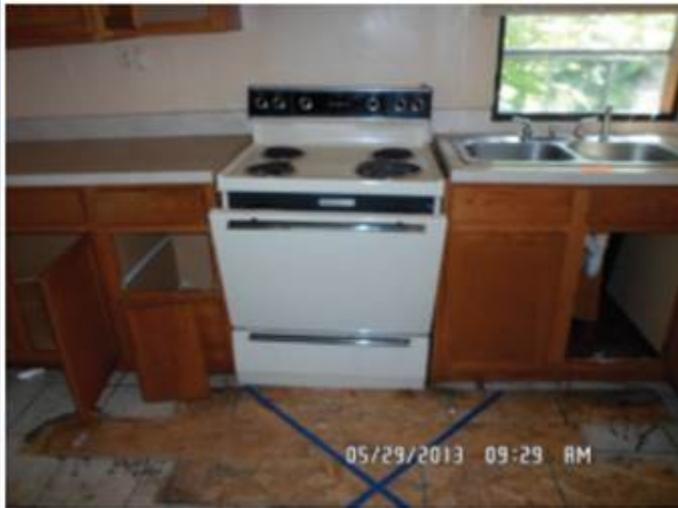
Property was acquired with rotted and unsafe flooring. Vendor failed to report the rotted flooring. There is photo documentation to support the damages were present prior to convey and this is in the FSM's photos.

Appliances fallen through rotten floor

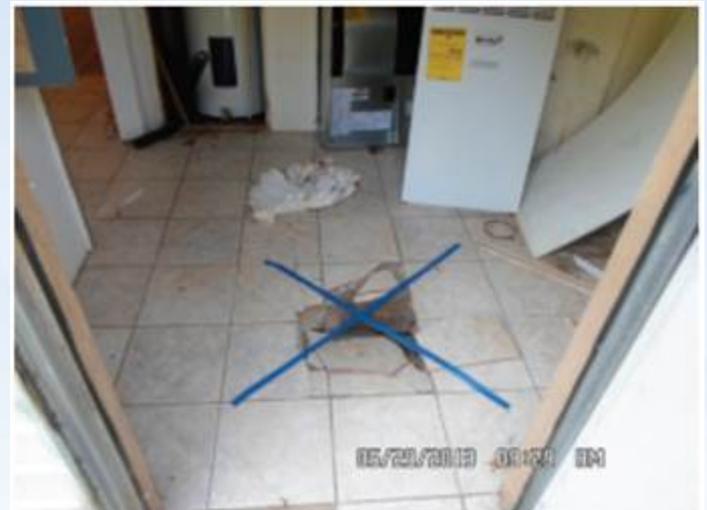
Rotten floor in utility room
