Safeguard
Properties

Basement & Foundation Damage

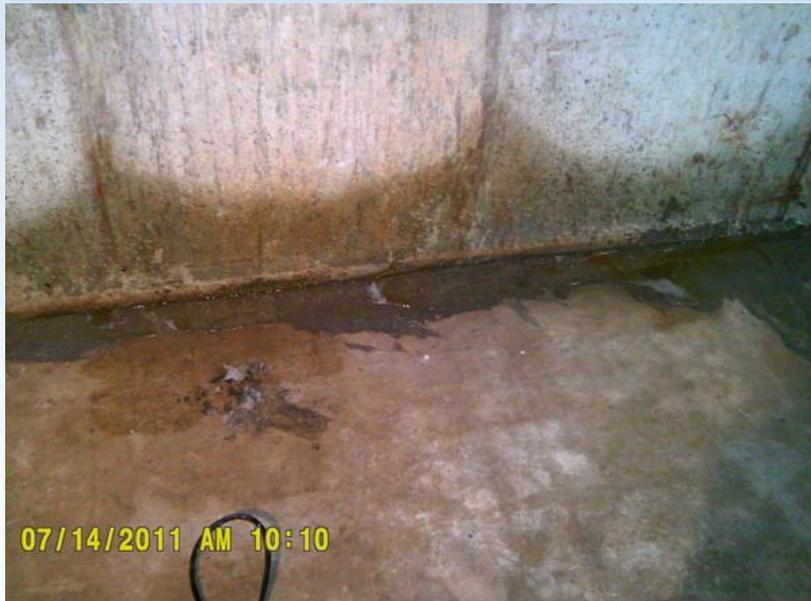
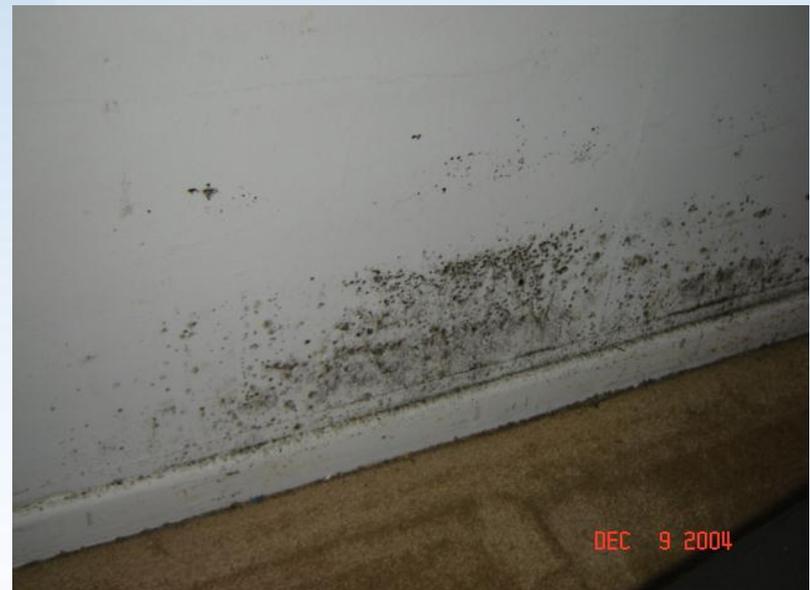
Example of Common Improper Source Identification:

There are many sources of discoloration; water intrusion, roof leak(s), plumbing leak(s), flood damage, etc. A large majority of discoloration issues are caused by foundation seepage, roof leaks, or flood damage. The number one answer submitted to Safeguard for source of discoloration is humidity; which is frequently inaccurate. Doing our due diligence to accurately identify the source of discoloration (or any damage) is unparalleled in preventing losses due to improper reporting.

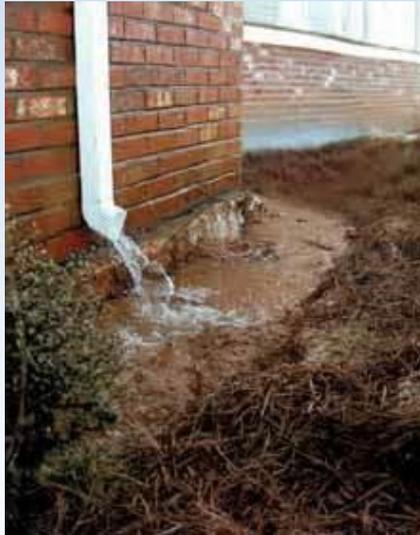
Improper Drainage

Drainage - How the home is situated on the property and how it interacts with the ground and environment surrounding it is important. To prevent water from pooling along the foundation and causing water damage or flooding in the home, check to see that the land slopes away from the home.

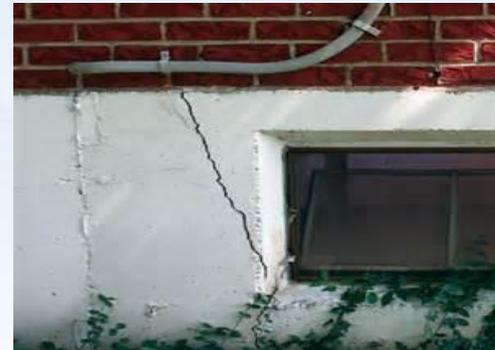
Foundation Cracks

Foundation - It is important to check for any unevenness, shifting, or cracks in the foundation which can lead to potential problems such as water intrusion.

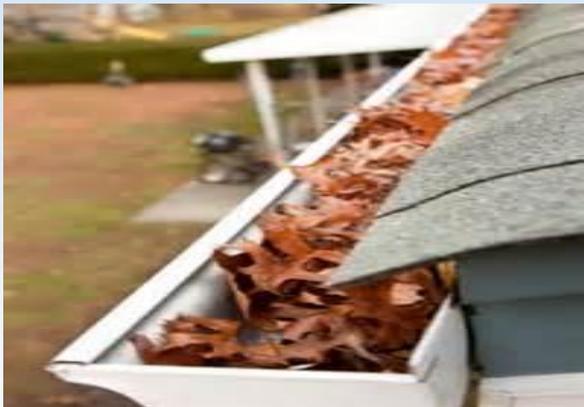
Clogged Gutters

Gutters and Downspouts - Clogged gutters will not direct water away from the house and could result in water intrusion.

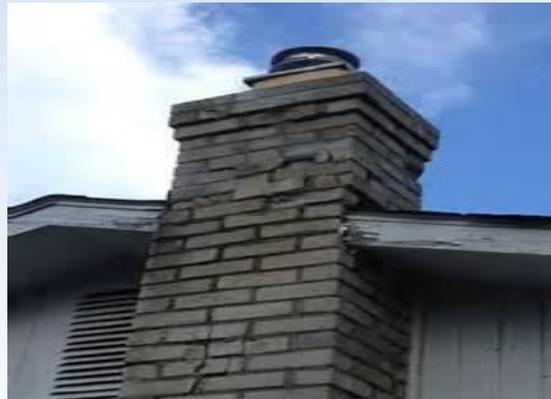
Chimney Damage

Chimney – As with all roof inspections, check the exterior of the chimney for damaged flashing, loose bricks, and missing mortar.

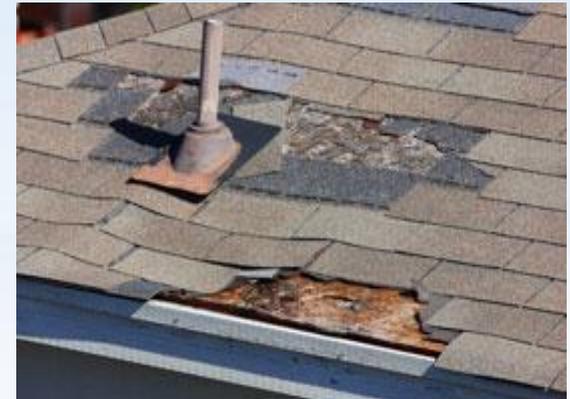
Roof Damages

Roof - Inspect the entire roof to include all flashings, skylights, vents, protrusions, drip edges, shingles, and soffits for any damage.

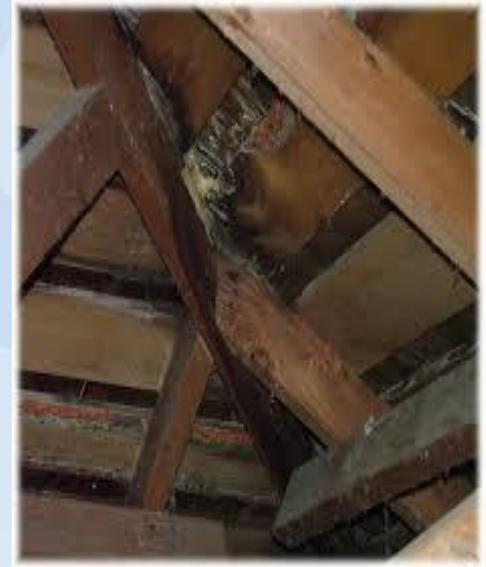
Attic Water Damage

Water staining, wood that is rotting on the underside of the sheeting or on the rafters, and light coming through the underside of the roof. If wood rot is suspected, use a screw driver or pen to push into the affected area. If area is soft, then the wood is likely rotted and needs to be addressed by removal and replacement of that area.

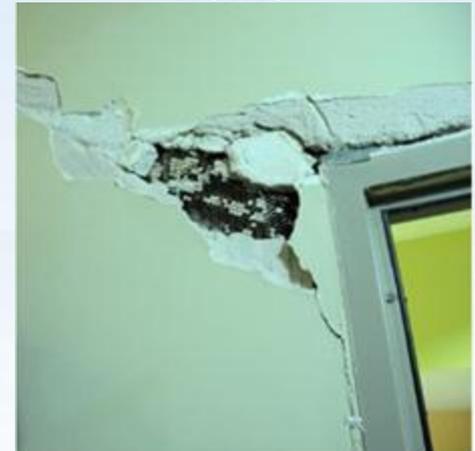
Deep cracking in door frame

Bulges, leaning walls, deep cracks in drywall/plaster (especially around door frames), windows/doors that do not close properly or line up incorrectly, sagging/uneven ceilings, cracks in the ceiling and uneven/rolling floors.

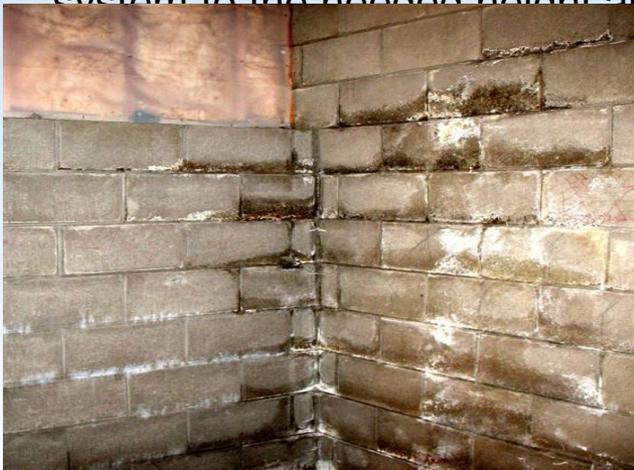
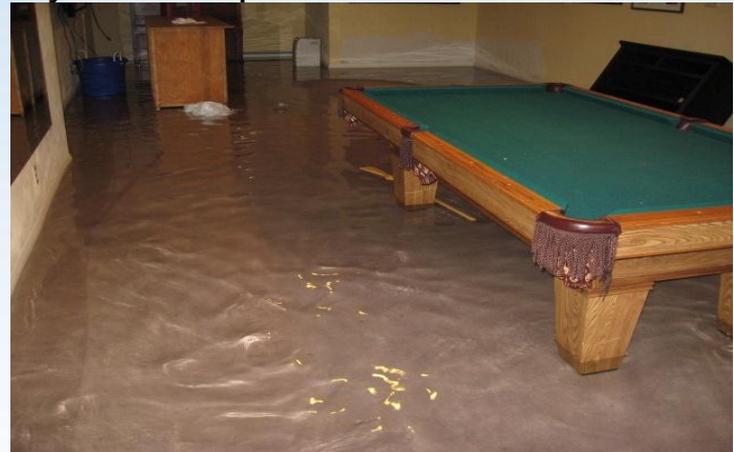
Once you've completed inspecting the attic and main floors, it is now time to inspect the basement for any damage and the cause of the damage. This may require to do an exterior inspection again once the damage has been identified, to correctly identify the cause of the damage

Signs to look for are:

- Musty, damp smell
- Cracks in the foundation
- Signs of any discoloration on walls or floors
- Tilting beams, cracking beams (wood) and sagging due to missing support columns.
- If issues are found with a beam, it is usually necessary to jack up the floor system to the needed height and complete any beam repairs.

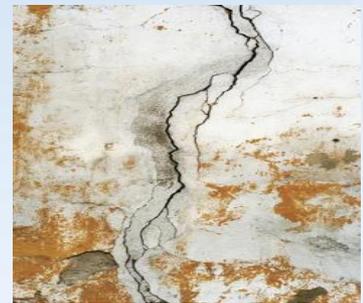
Rotational Crack

Rotational cracks (also called settling cracks) are caused by one section of a foundation settling while another section is stable. This causes the settling section to "rotate" away from the stable section, as if the bottom of the wall is on a hinge. The cracking will be V shaped from bottom to top with the top of the crack wider than the bottom. This condition will continue to worsen unless correctly dealt with.

Patching the crack will fail as the crack will continue to grow in width. The settling section of the foundation needs to be buttressed by concrete or steel column(s) or piers from the exterior. Then the crack can be repaired from the exterior in the same manner as a vertical crack (see above). The columns or piers should be completed by a company specializing in this type of repair.

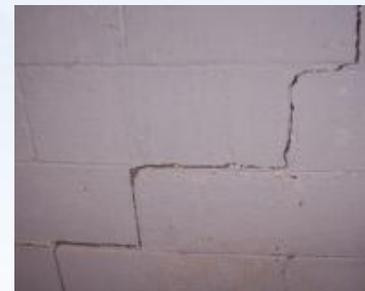
Step Crack

Step cracks when inspecting a block or stone foundation the cracking involved will usually follow the mortar joints and is called step cracking due to the cracking pattern. Otherwise the cracks will be similar in appearance and pattern to foundation cracks in all other respects.

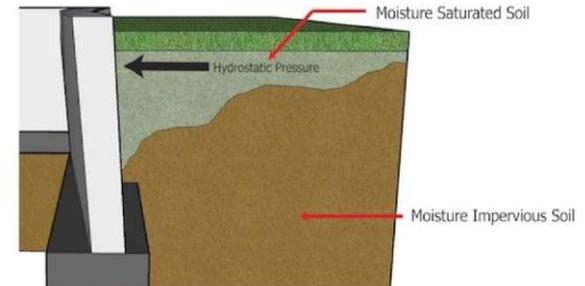
Leaning Wall

Foundation Cracks:
Lateral Movement - Side View
Vertical Cracking

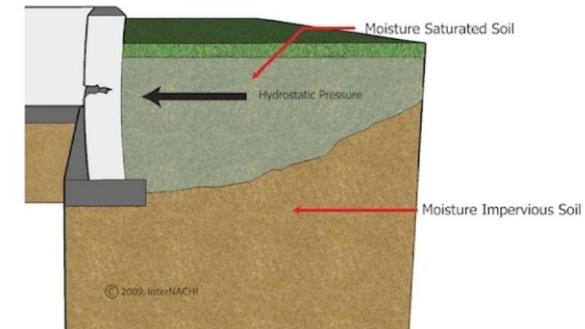
Buckling Wall

Horizontal cracks (also call buckling cracks) are serious and need to be addressed immediately. These cracks will run along extensive lengths of a foundation wall and be more or less horizontal.

Foundation Cracks:
Lateral Movement - Side View
Horizontal Cracking

The cause here is a foundation wall that is about to collapse inward from excessive pressure from the outside. To deal with this type of cracking the interior wall needs to be buttressed (braced) and then the exterior of the wall excavated to relieve the pressure on the wall. Permanent repairs vary according to the situation, but generally the wall needs to be pushed back into place and additional concrete buttressing columns and/or steel strapping need to be poured in place/installed on the inside of the existing wall. This work should be completed by a company specializing in this type of repair.

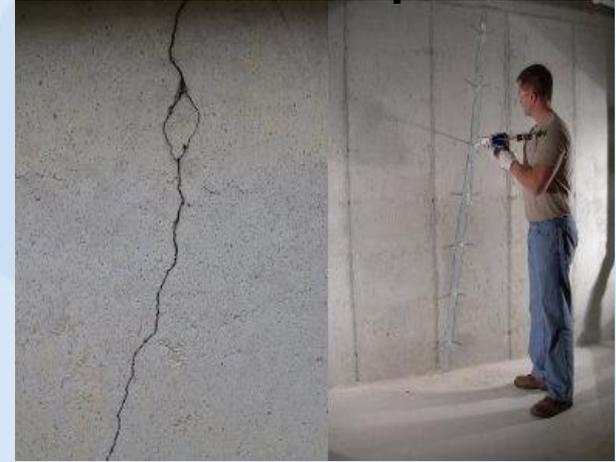
Interior Repair

Can be repaired by epoxy or poly-urethane base products if the hydro-static water pressure from the exterior is 40 PSI or less. If the PSI is more than 40, the work needs to be done from the exterior by excavating down to the foundation footing at the site of the crack and injecting an epoxy or poly-urethane based product into the crack from the exterior side. Although this work can be done by the P&P contractor, the measuring of the hydro-static water pressure should be done by a company specializing in this type of service.

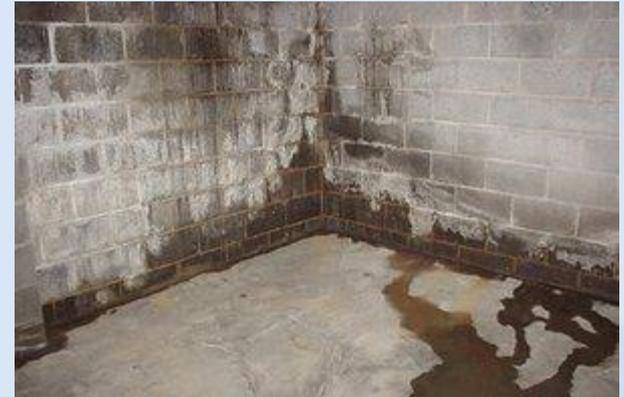
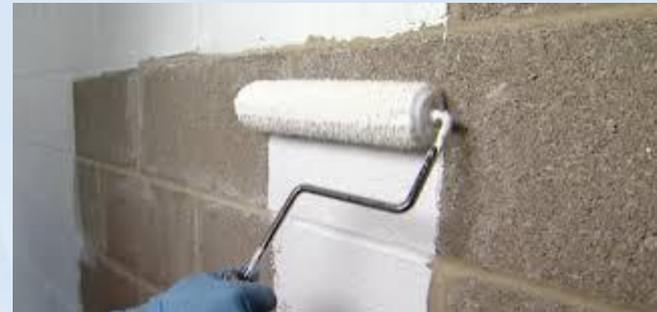
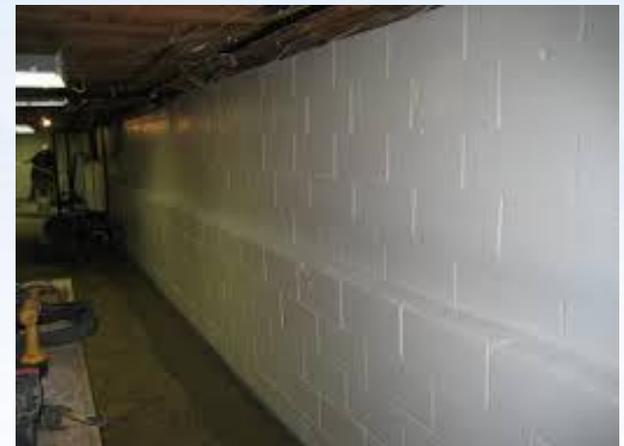
1. Prep the area
2. Fill cracks and holes
3. Apply 2 or more coats to ensure proper coverage with a 3/4 in. nap roller, or good quality nylon bristle brush
 1. If spraying, follow the manufactures directions and ensure proper application
4. The end result is a membrane that prevents water from entering the property

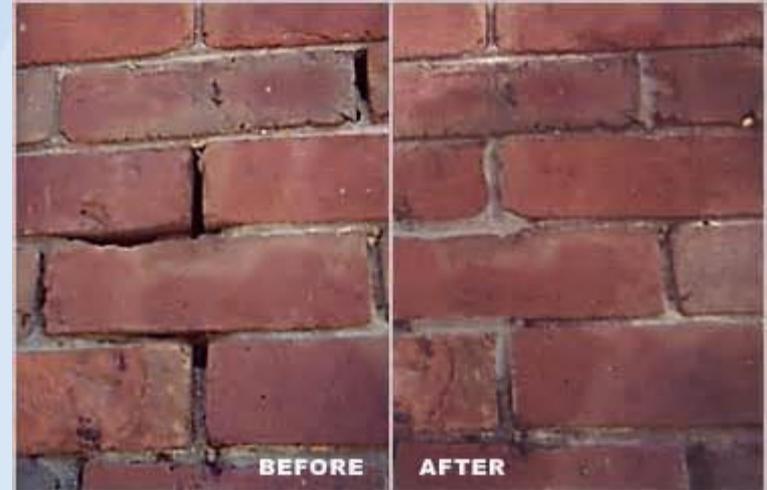
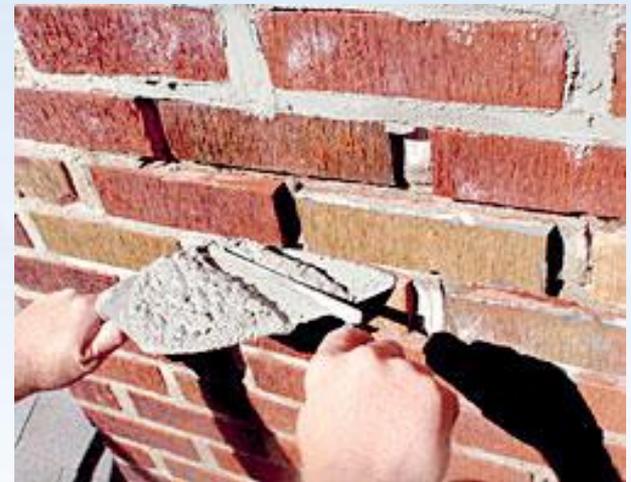
Over time, mortar tends to deteriorate. Not only are cracked and deteriorating mortar joints unsightly, but they also diminish the integrity of the surface and can allow water to get behind the brick or block and cause major damage. Vendors need to place bids to tuck-point the brick or block foundation to avoid these problems. Tuck-pointing is the process of removing and replacing cracked or missing mortar.

1. Chip away cracked and loose mortar using a slim, cold chisel and a hammer; remove the existing material to a depth of approximately half an inch. Fill cracks and holes
2. Prepare your mortar and allow the mix to set for about five minutes. Brush the joints with fresh water.
3. Apply the mortar using a pie-shaped trowel called a pointing trowel.

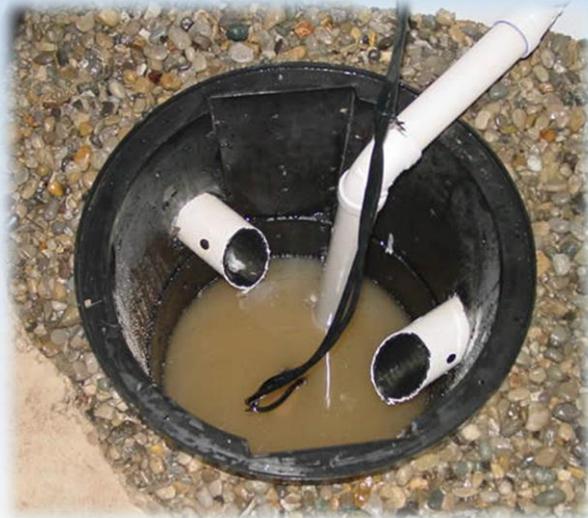
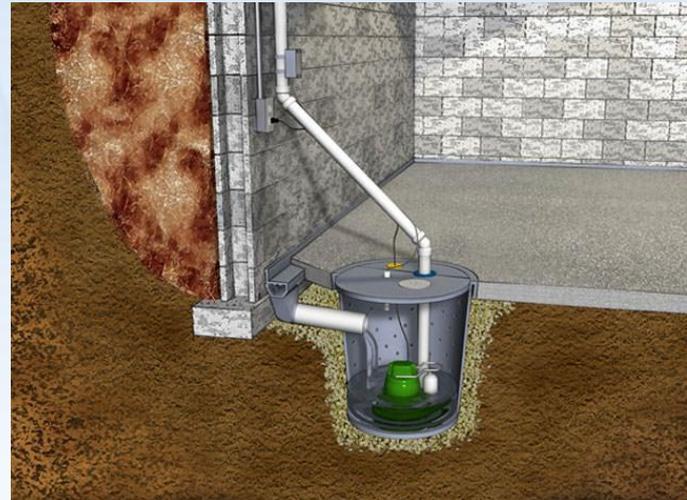
If we find a flooded basement due to a non-working sump pump, we must first remove the water from the basement. Then, if necessary, we replace or repair the sump pump based on investor guidelines and client parameters and, if necessary, make sure that the electricity is on.

If we find a sump pump not operating and there is no current water damage, we test the pump to determine why it's not operating (lack of electricity, mechanical failure, etc.) and then report its condition.

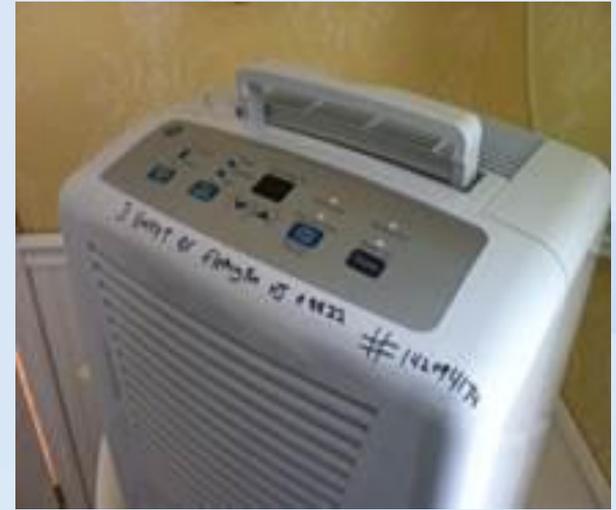
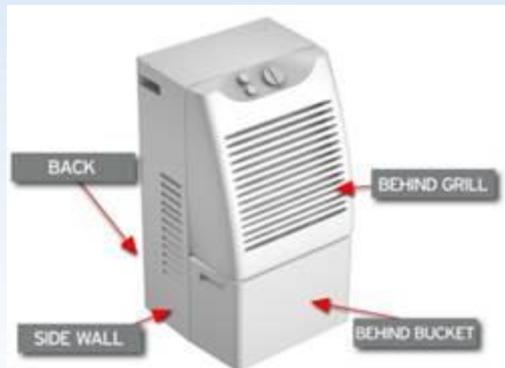
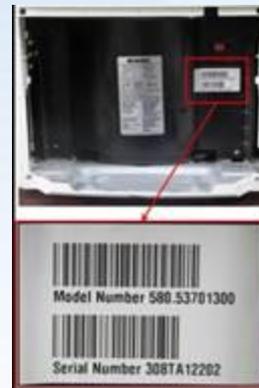
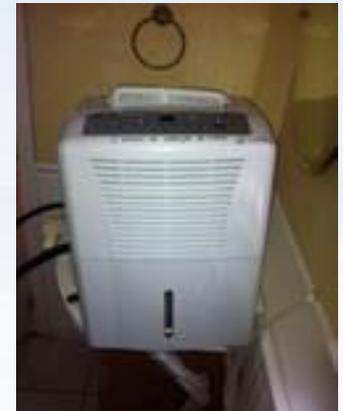
During installation, vendors must label the installation property address and the work order number, clearly written in permanent marker, on the dehumidifier. A photo showing the dehumidifier with the markings is required in the corresponding update. The update must include a clear picture of the serial number plate as well as notation of the serial number of the dehumidifier in the comments section.

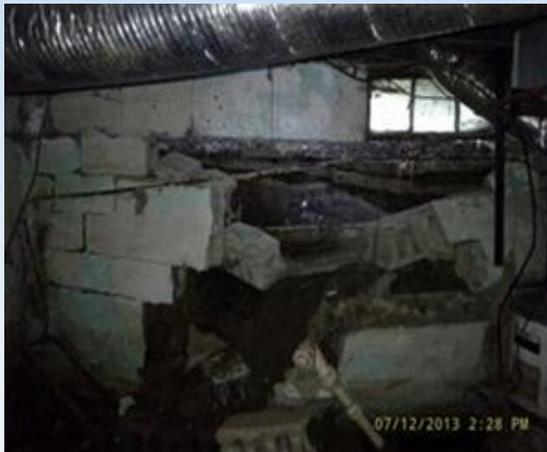
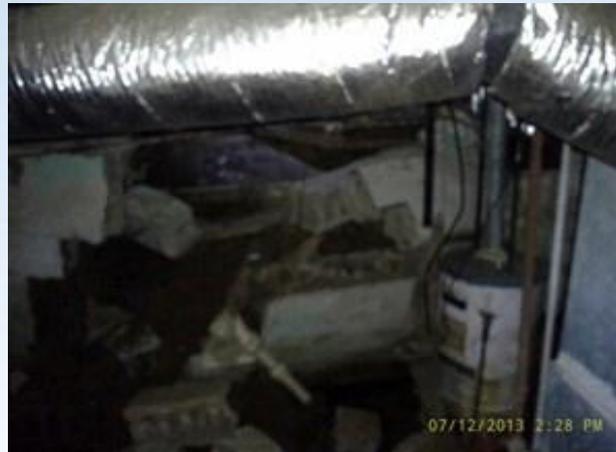
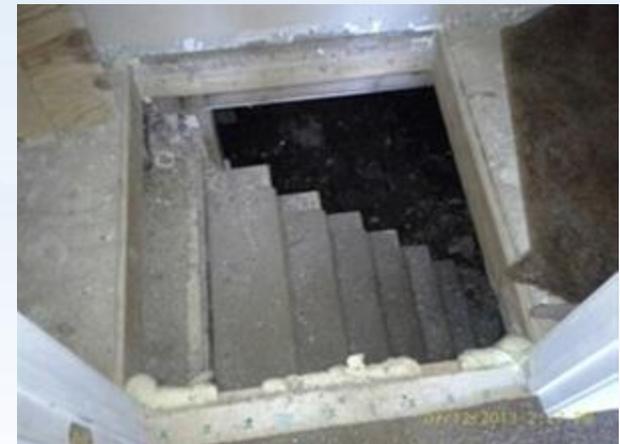
This property was conveyed to HUD with a front foundation that was crumbling and collapsing due to structural damages in the basement. The basement was filled with water, debris and safety issues. The building commissioner inspected the property, found it to be structurally unsound and deemed it uninhabitable.

Vendor failed to report there was a basement present.

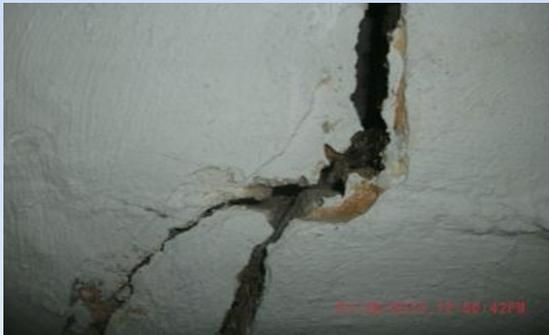
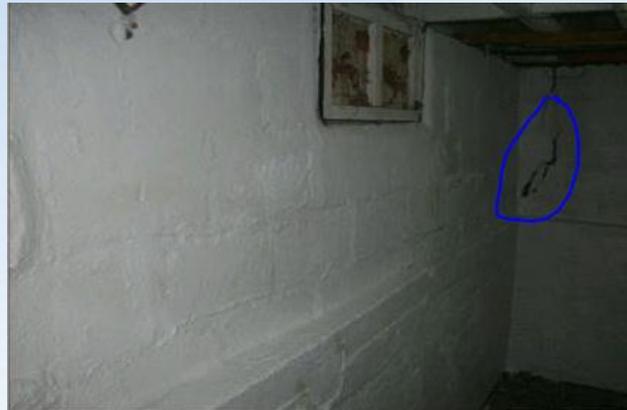
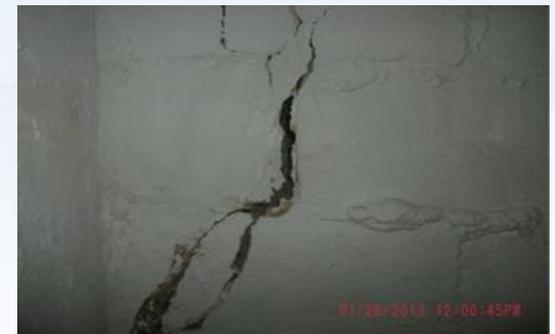
Property was acquired with structural damage in the basement

06/19/12 Dry locked basement, filled cracks, photos show some cracks still present after epoxy and dry lock

The repair to the cracks was temporary and did not resolve the underlying issue; therefore, the basement wall continued to crack.
