Completing a Roof Assessment and Determining an Active Leak

Numerous work order services will require you to complete a full roof assessment and determine if there is an active leak on site. The below information will help you define both the assessment and an active leak.

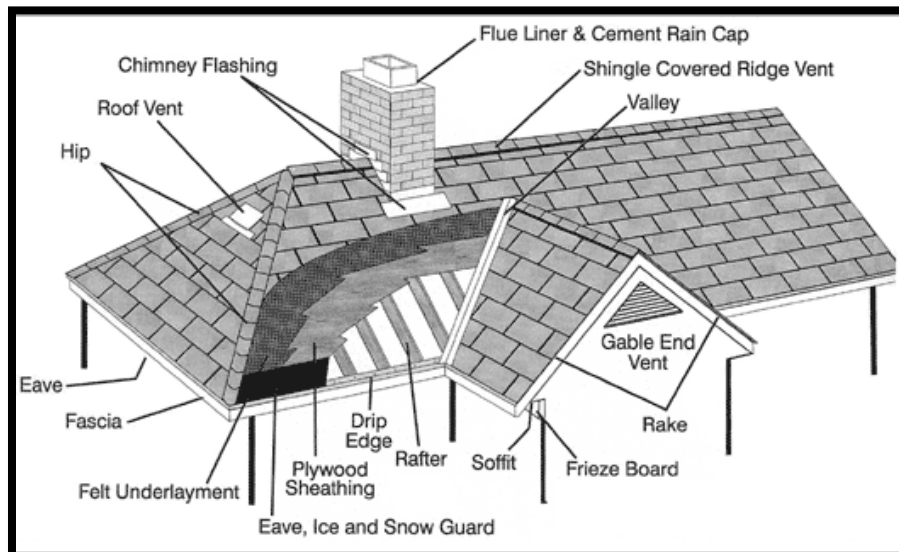
- Assure you and your crews understand all working components of a roof that is subject to inspection and possible repair:

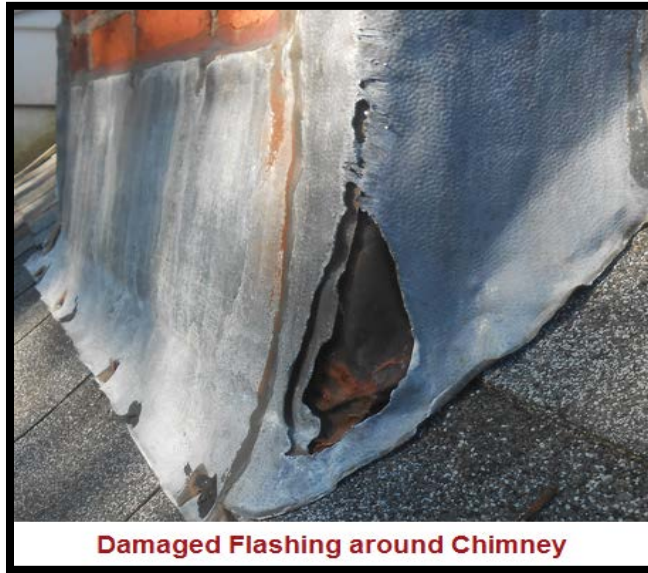
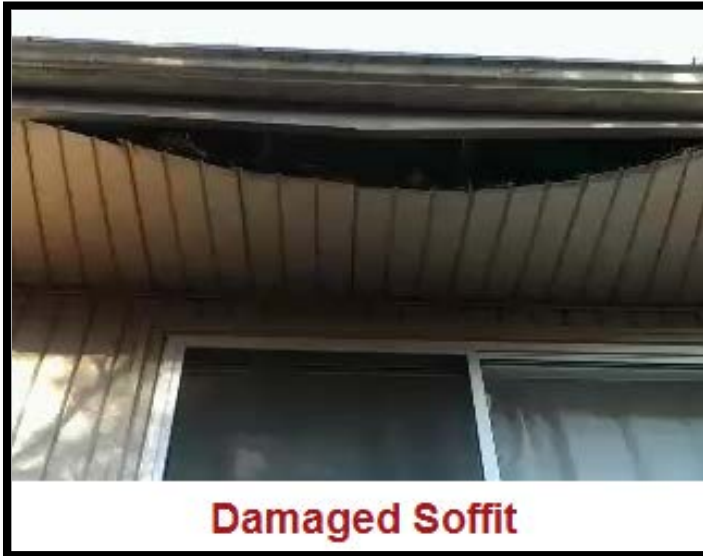
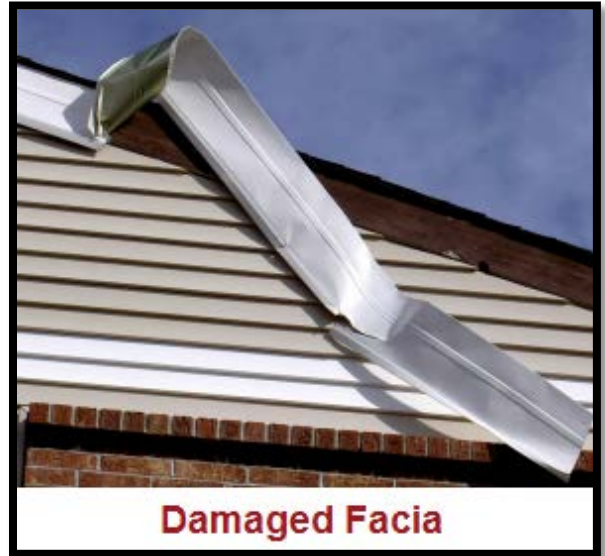
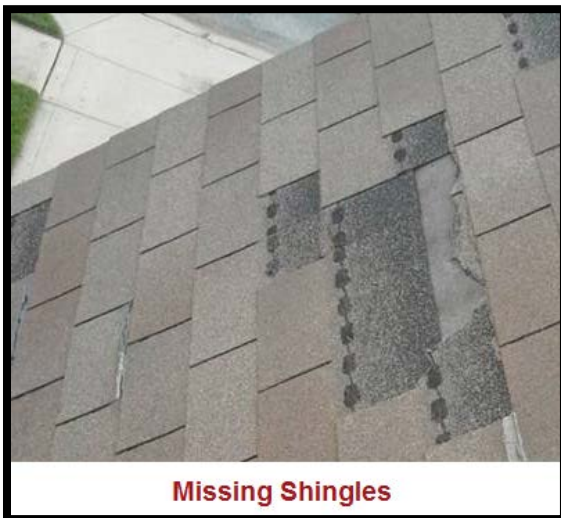
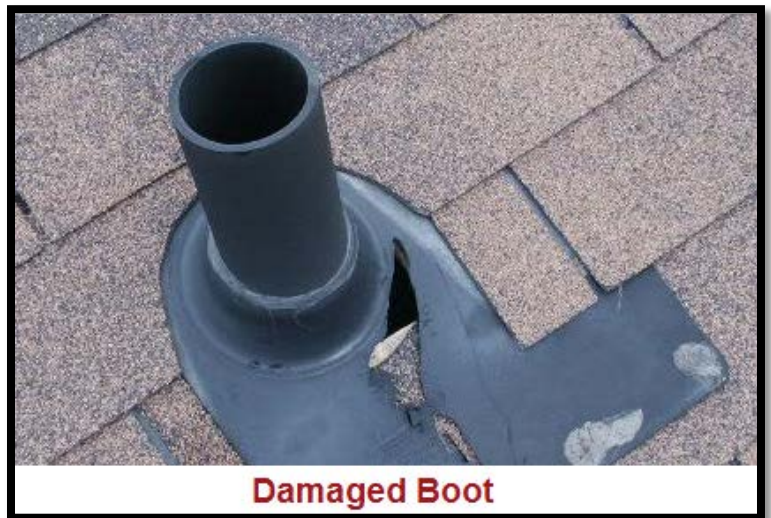
- Assure you and your crews understand the types of damages that can cause active water leaks within the home. Examples are show below:

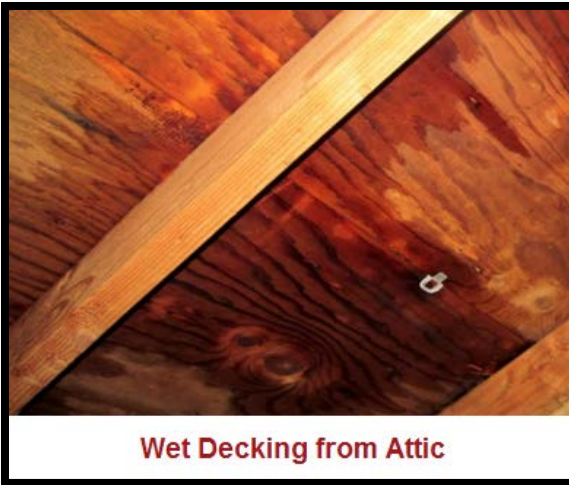
Wet Decking from Attic

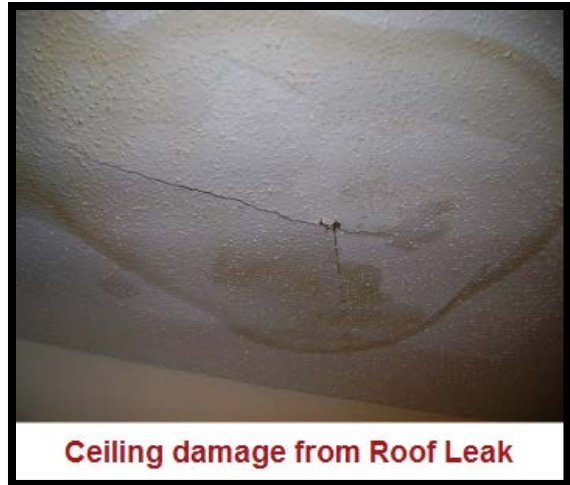
Ceiling damage from Roof Leak

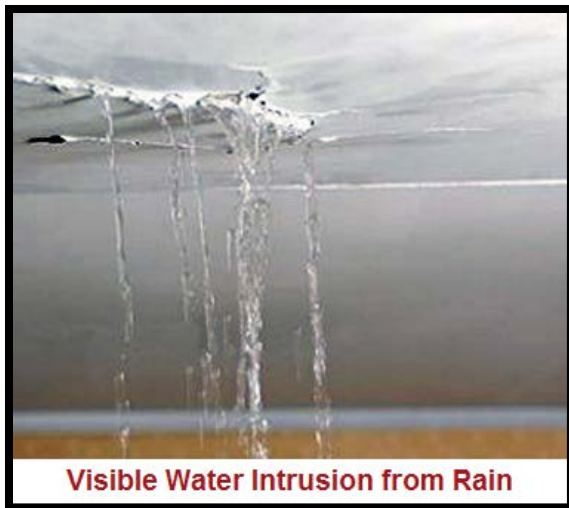
Visible Water Intrusion from Rain

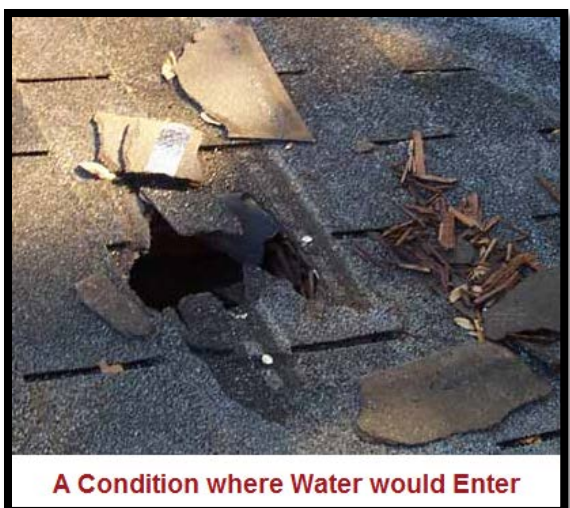
A Condition where Water would Enter

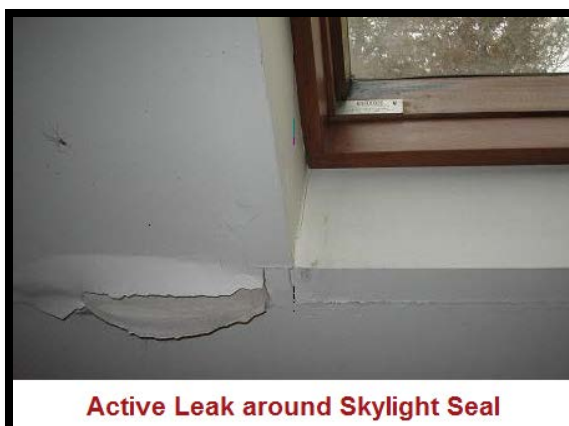
Active Leak around Skylight Seal

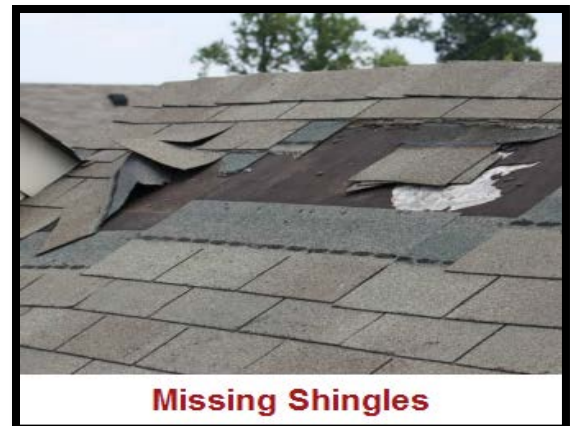
Missing Shingles

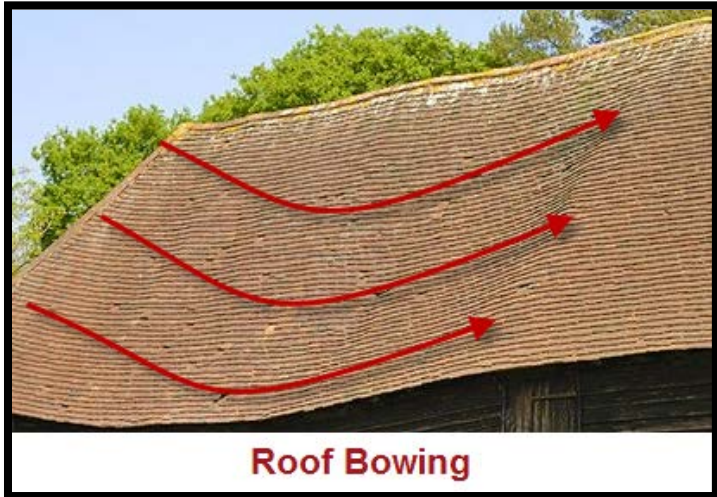
- Below are examples of roof that would not be considered accessible, and requirements that must still be completed regardless of roof condition.

- Use a ladder to document roof level and review for all issues and damages
- Complete interior assessment on all ceiling surfaces, including the attic, second floor rooms, etc.
- Consider alternate technology that would allow for aerial inspections, such as drones.
- Document and report all damages; provide necessary bids to repair
