# Groundwater Seepage

The following guide can be used by you and your crews when assessing seepage at a property. Bear in mind that this guide is not all-inclusive, and should be used in a supplementary fashion only. Always act in accordance with the work order instructions at each property.

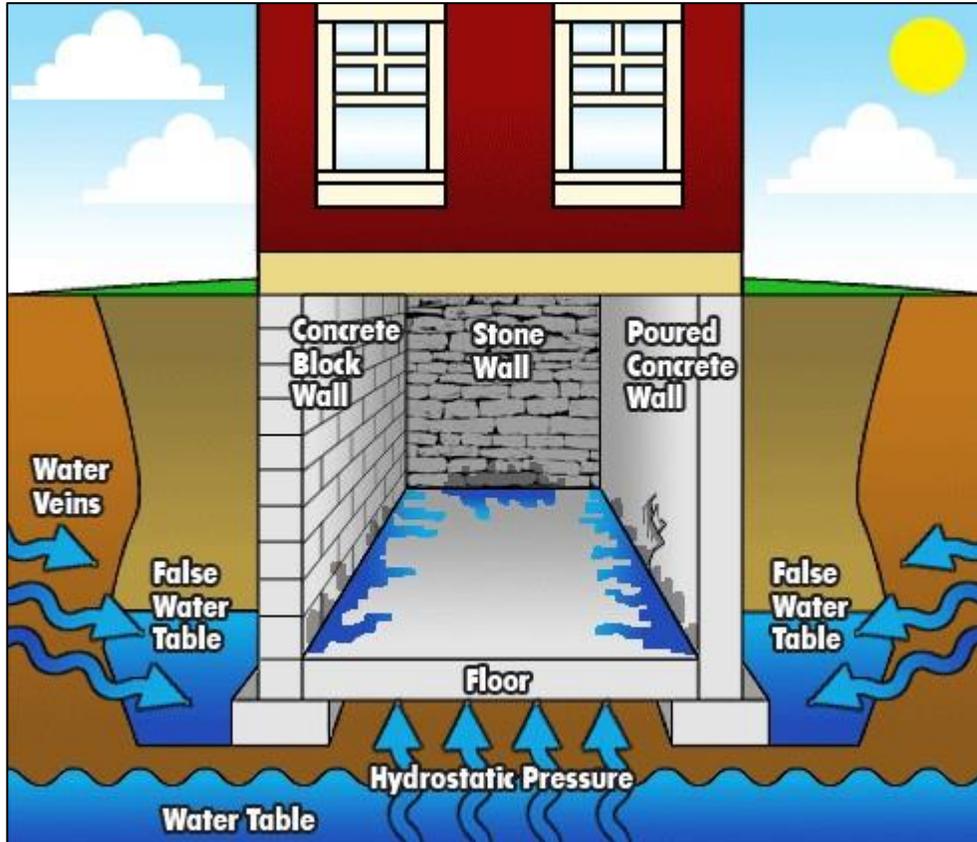
The level at which water naturally sits is referred to as the “water table,” and it will vary from one location to another. A main factor contributing to the height of the water table is proximity to large bodies of water. For example, a home in Cleveland that is close to Lake Erie will typically have a much higher water table than a home in Nebraska or Kansas. When heavy rain or snowmelt occurs, the soil near the surface becomes saturated and the water table rises. When the water table rises beneath a foundation, it creates hydrostatic pressure that will force water through any small cracks or imperfections in the foundation and create leaks.

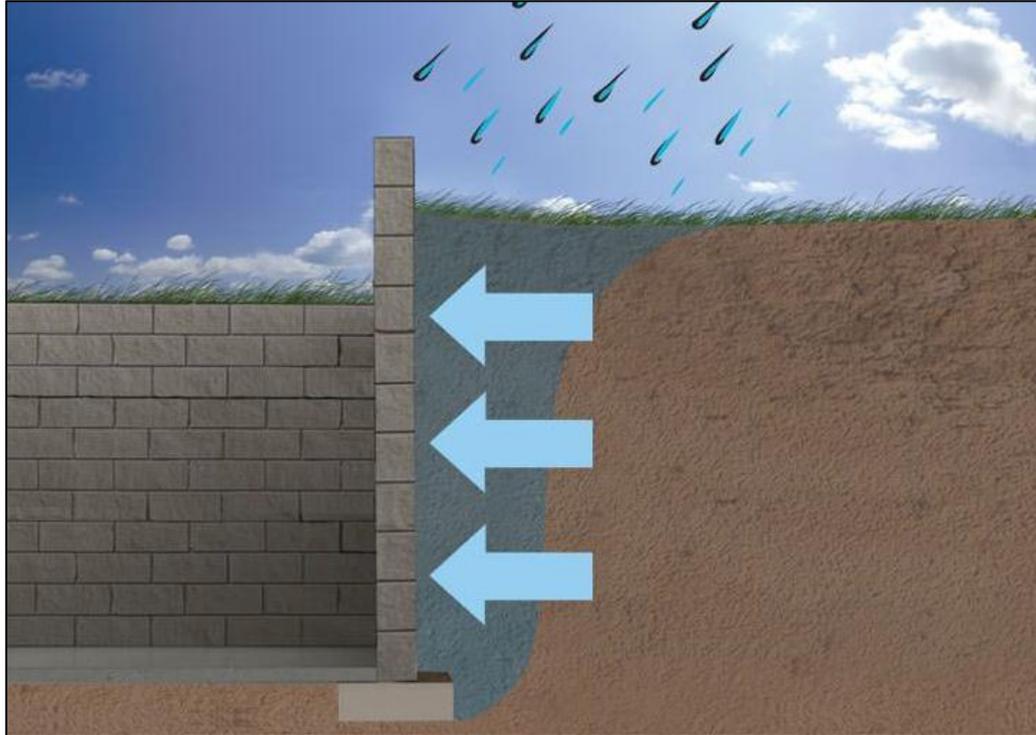
As the soil near the surface becomes saturated and absorbs water as a result of rainfall or snowmelt, the soil can expand and create sideways (lateral) pressure against the foundation walls and force water through any foundation defects and create a leak.

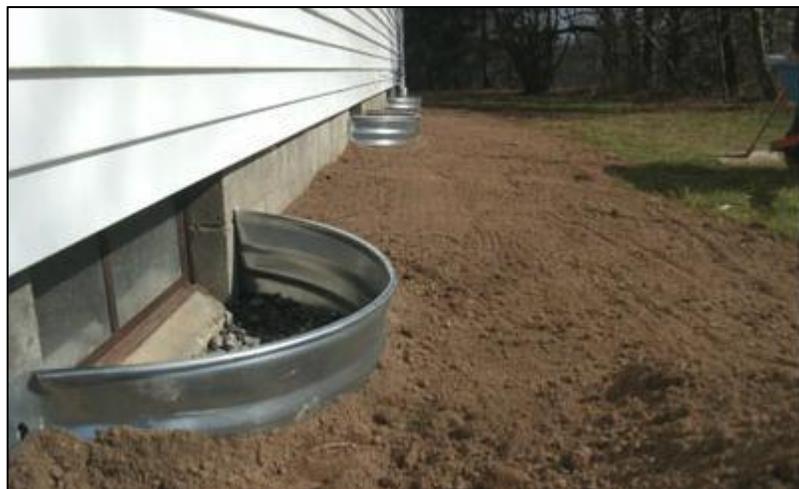
This is the area that allows a basement window to exist below grade. Water can easily accumulate here and seep in around the edges of the window. Equally, if the window panes are compromised, water can enter through the cracks or breaks.

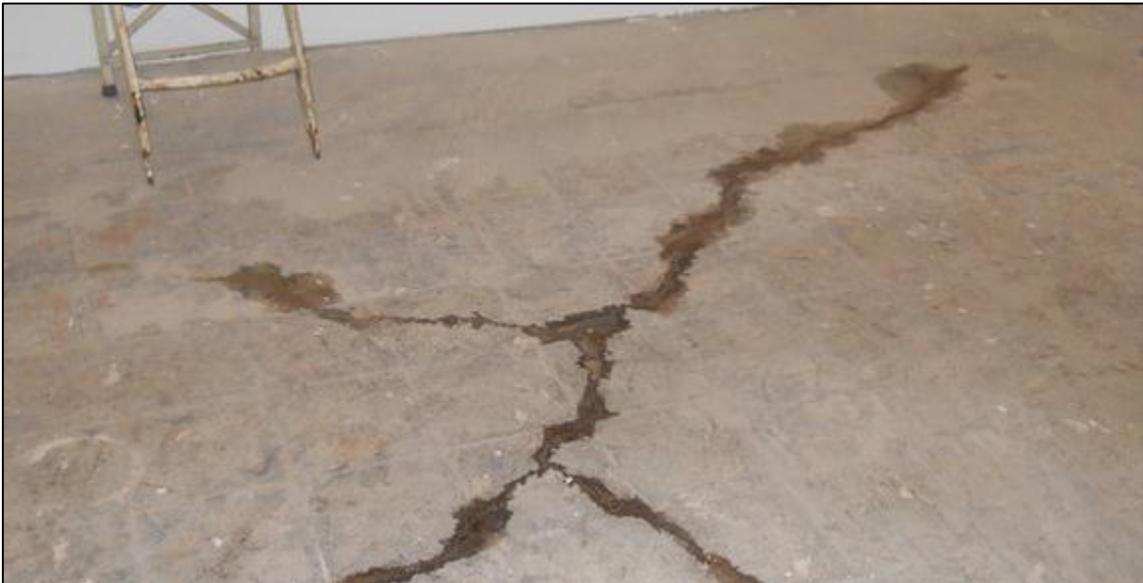
Basement floors are typically 2 – 4 inches thick, and typically have no structural role in the home's foundation. They are there to provide a clean, solid base. Hydrostatic pressure presses upward on the basement floor, causing it to crack. These cracks will allow water to seep into the basement when the water table rises.

Sealing floor cracks to solve a seepage problem is not usually recommended - this will only allow the water pressure to build and move elsewhere. It is usually more effective to install an Interior Drain Tile System. This system relieves hydrostatic pressure by draining the water beneath the floor and directing it to a sump pump.

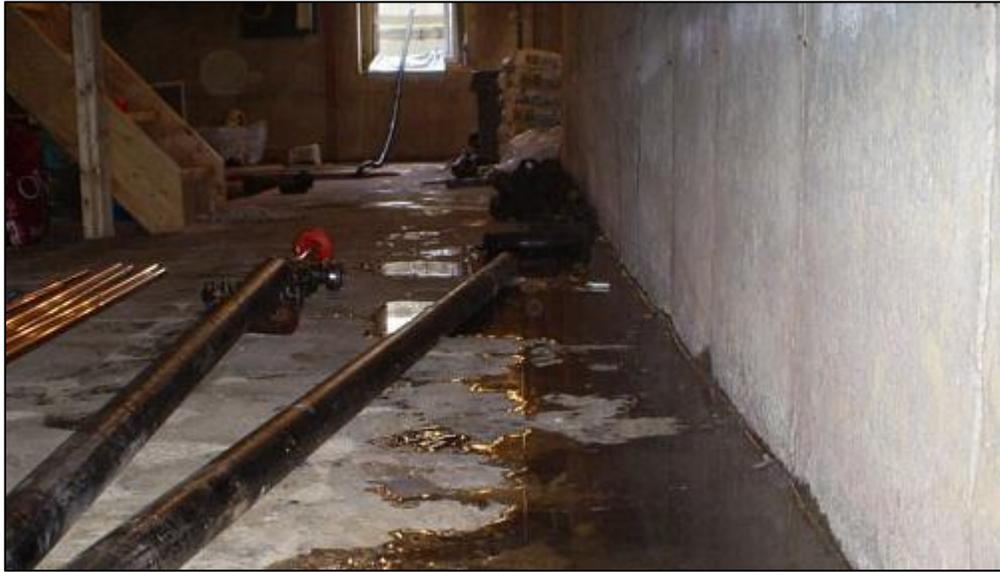
When foundations are built, they are set on a footing – a wide concrete slab that follows the perimeter of the home. The foundation walls sit on top of the footings, and the junction of the wall and footing is referred to as the cove joint. This joint may have minute cracks that allow water to be forced into the basement by hydrostatic pressure.

This type of leak can be identified by water seepage where the basement walls and floor meet, with little indication of water having traveled down the basement walls (such as in the photo below.) Recommended course of action is installing an Interior Drain Tile System. This system relieves hydrostatic pressure by draining the water beneath the floor and directing it to a sump pump. Epoxy or urethane injection at this site is not typically advisable since this would do little more than create a damming effect. The water pressure would continue to build up under the slab and force its way up elsewhere.

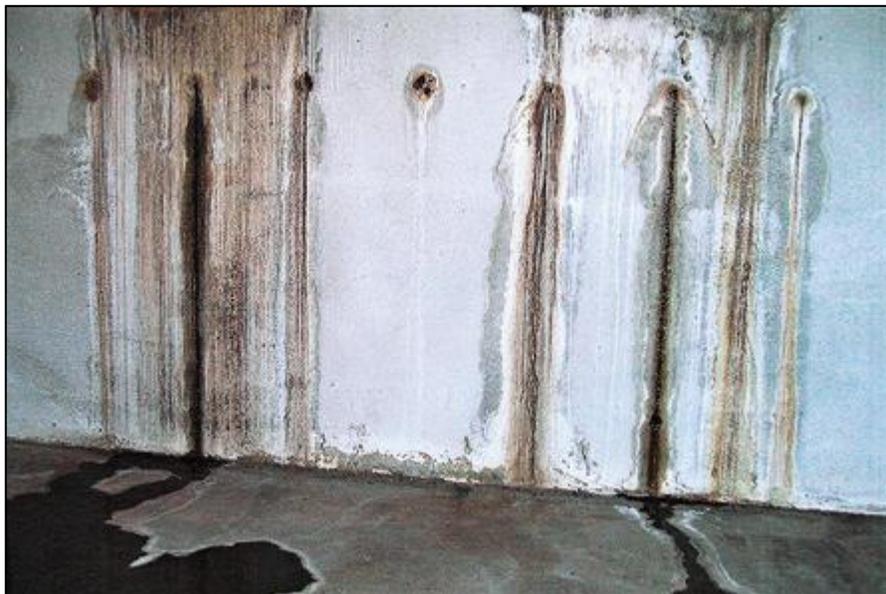
Concrete walls are poured into forms that are set on either side of the wall. These forms held together with “tie rods” that prevent the forms from separating under the lateral pressure of the concrete while it is still wet. When the forms are removed, the ends of the ties are either snapped off or removed and the hole is filled. This is a common point of water intrusion, as any voids around the tie and failed patches are a direct path for water to follow into the property. This may be referred to as a pinhole leak, a rod pocket leak, or a tie backer hole leak.

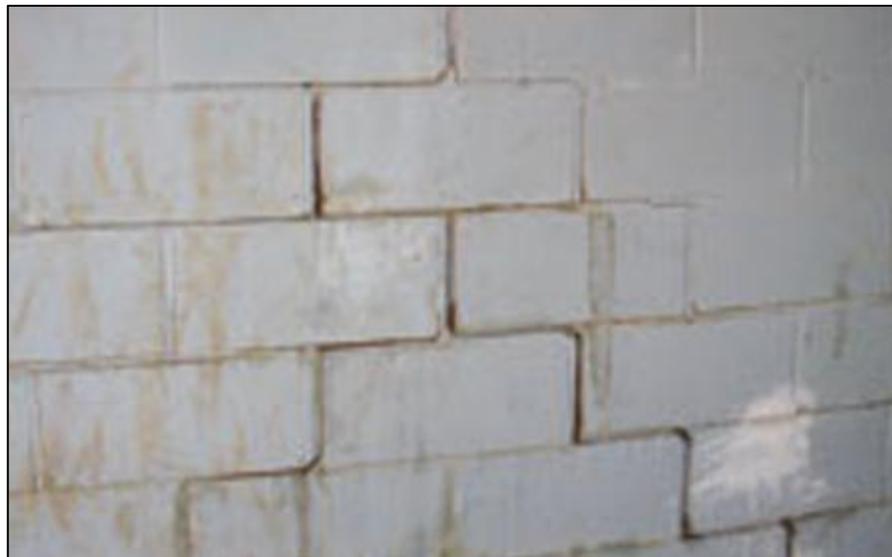
Minor settling or lateral pressure can cause the joints that hold brick, block, or stone together to separate and create a source of seepage. Mortar can additionally deteriorate over time, and an improper mix can be porous and allow seepage. Recommended course of action is an Interior Drain Tile System or an Exterior Waterproofing System.

Tuckpointing can be used to address dampness, but is not advisable for interior repairs if there is active water intrusion. This may create a damming effect and cause pressure to build up elsewhere.

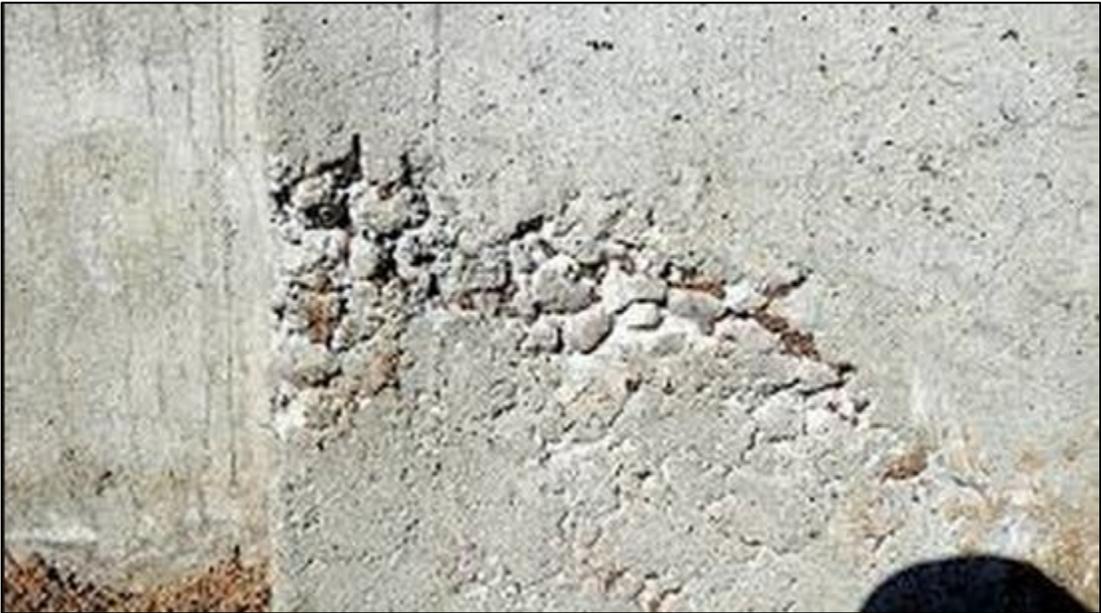
Insufficient mixing of concrete or mortar, or flaws in the pouring process can create porous spots that will allow seepage over time. Some building materials (e.g. concrete block or brick) are porous by nature and can allow seepage as well. Recommended course of action is installation of an Exterior Waterproofing System.

“Honeycomb” imperfection in concrete wall:

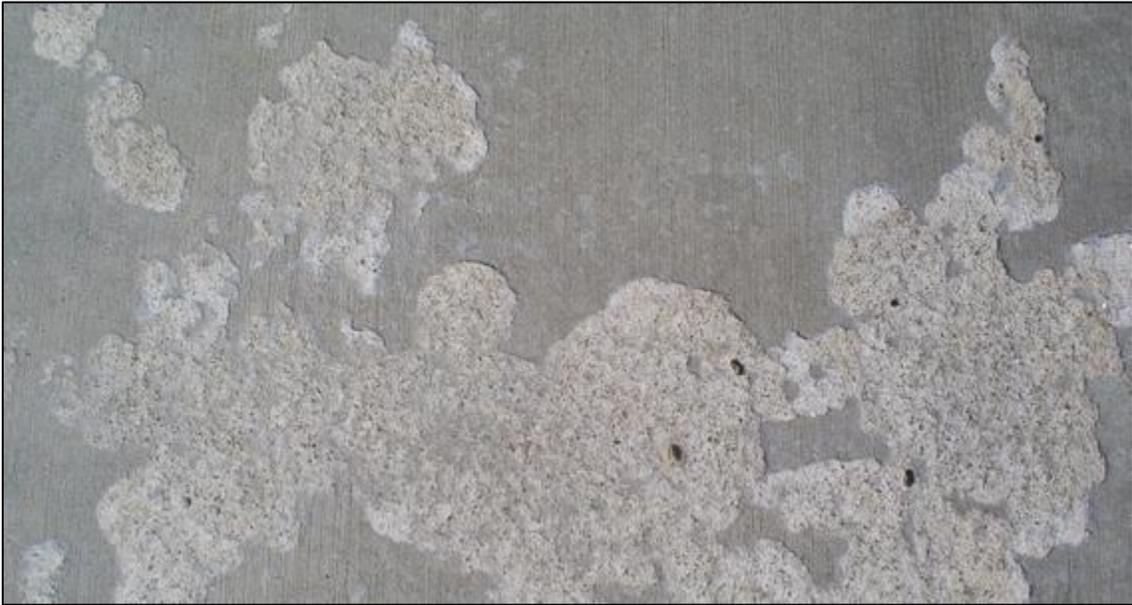
“Spalled” concrete:

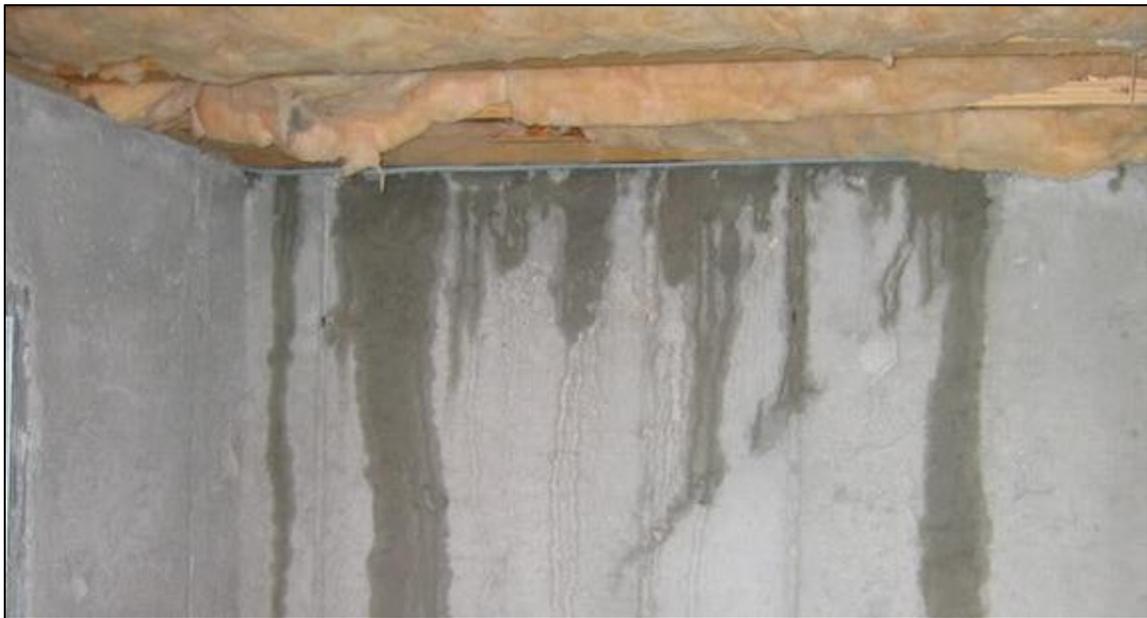
Foundation walls are joined to the framing of the first floor walls with a “sill plate” that forms the base of the framed wall. In certain instances there may be a slight gap between the sill plate and the foundation wall that will allow water intrusion. Water entry at this location is often related to a negative grade (earth sloping toward the foundation rather than away,) or structures like decks or patios that are improperly pitched and allow rain water to run toward the house.

You may also find improper or defective flashing is the culprit for this type of leak. Homes often have a brick veneer on the exterior, and water will find its way behind the brick to the wall sheathing. Weep holes will allow this water to drain away from the property at the bottom of the wall, but defective flashing may allow water to find its way inside instead. Recommended course of action is replacement of brick flashing.

Recommended course of action is installation of an Exterior Waterproofing System. However, if the grading issues can be corrected without extensive time and effort being expended, this may be an acceptable solution as well.

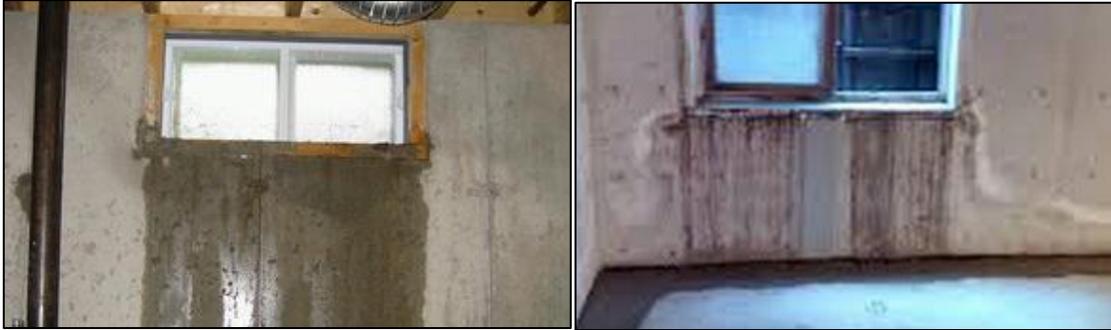
Basement windows are generally found either at or below grade, and the edges of the windows are susceptible to water intrusion. A metal, brick, or wood retaining wall, referred to as a window well, is used to hold back the earth around the window. Water can easily collect in this area and seep in around the base of the window, or through cracks or breaks in the glass. Recommendation is to ensure window well drains are present, not clogged, and properly routed.

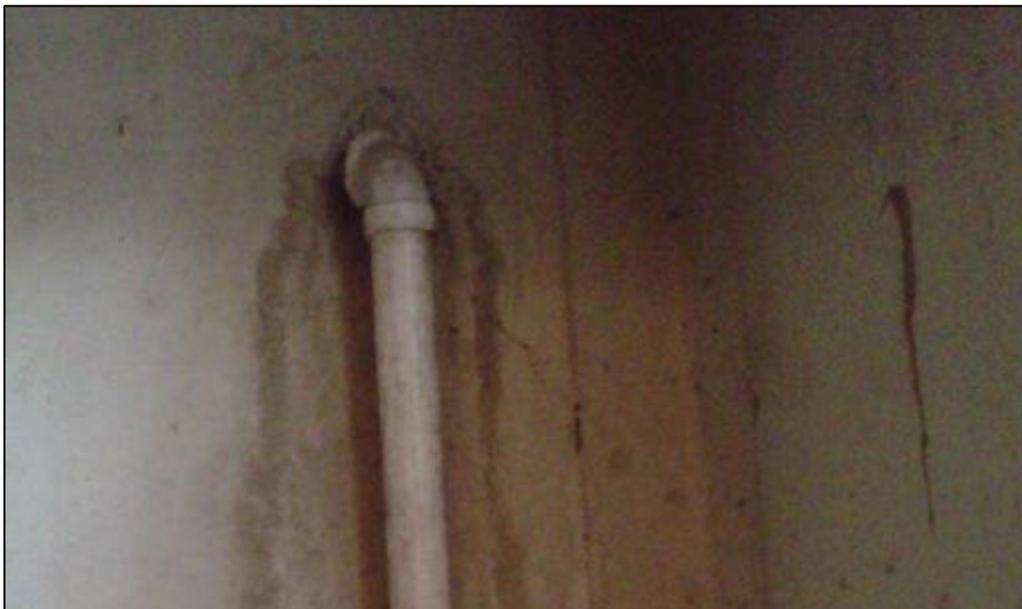
Leaks can occur from wall piping installation. A larger core hole is drilled in the foundation, and then the smaller line is fed through. There is a cement cap placed on both the interior and exterior faces of the foundation. Over time cement breaks down and the water flows in around the piping. Leaks around pipe penetrations should be patched.

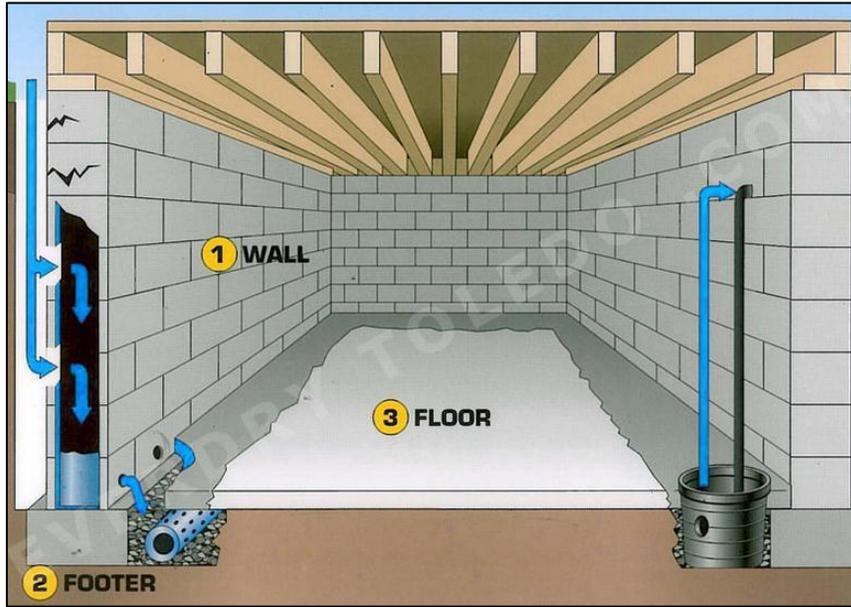
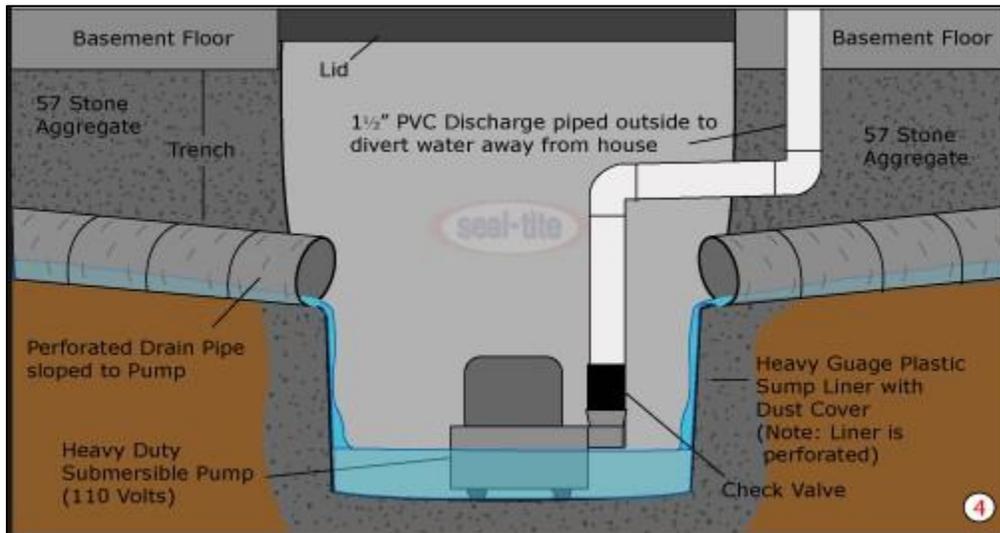
Interior drain tile is embedded in washed gravel to create better drainage and is wrapped in a “sock” of filtration fabric to keep it clean and flowing. It takes in ground water through its perforations and carries it to a sump basin where the sump pump discharges it from the basement. When installed properly, interior drain tile requires no maintenance.

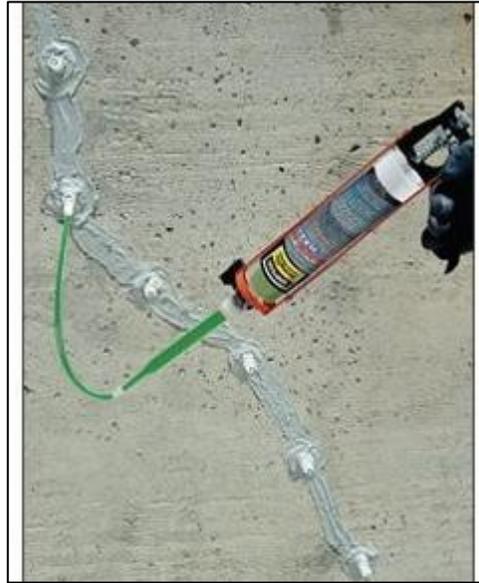
Foundation wall cracks can be repaired from either the interior or the exterior by use of a two-step process where a resin is injected into the crack, and sealed with a paste on the interior wall.

Epoxy injection:

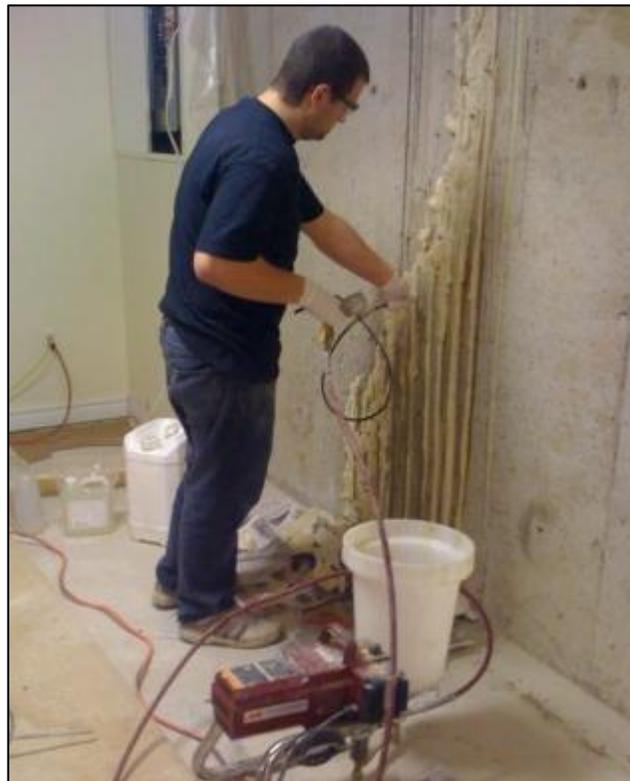
Urethane foam injection:

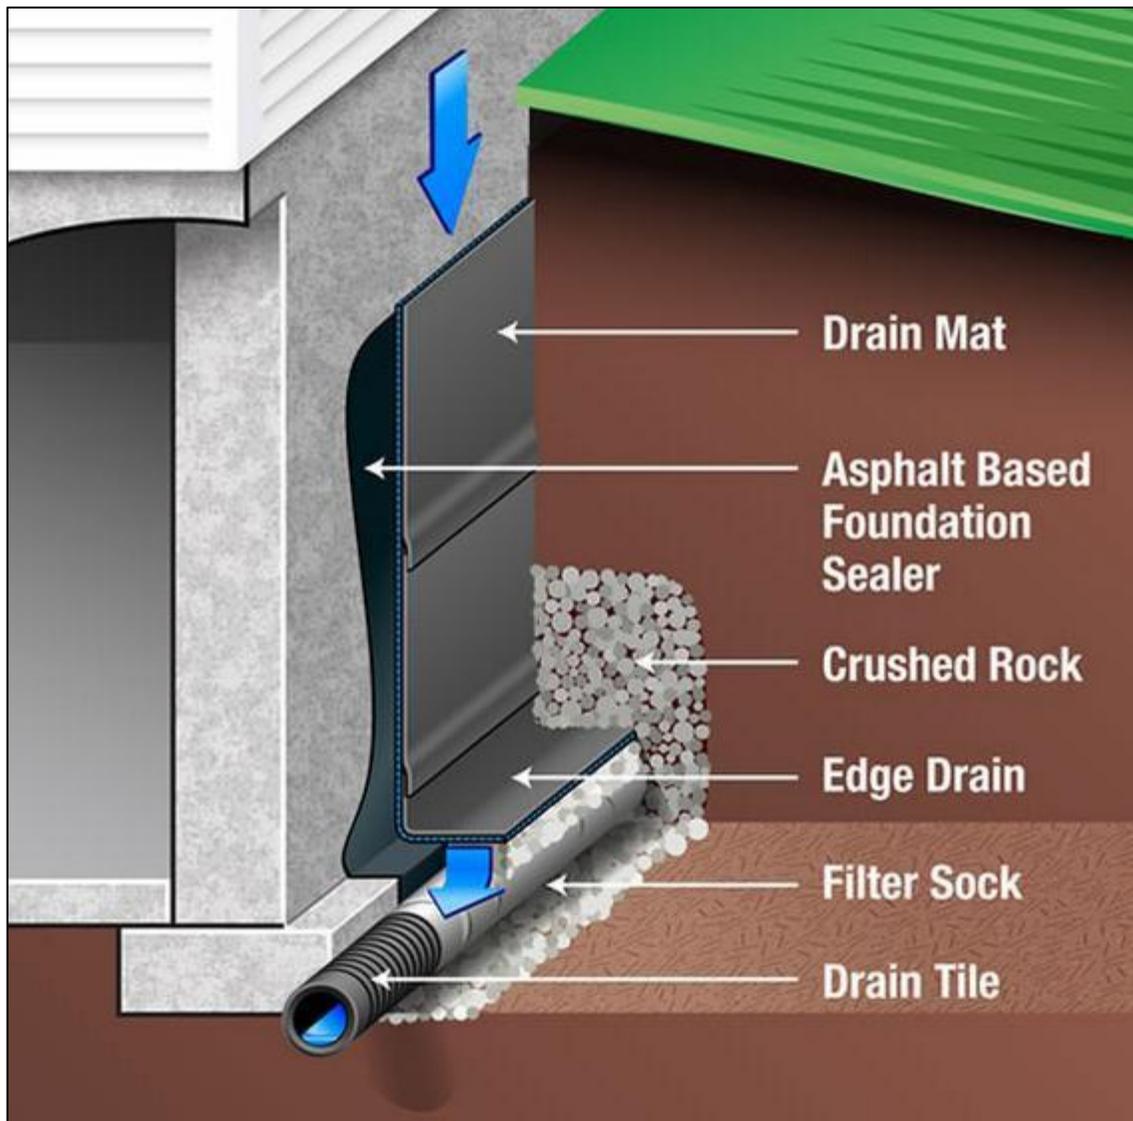
This is a preferred option in finished basements, as opposed to tearing out all interior drywall in order to repair the leak from the inside. The soil around the foundation wall is excavated, and a waterproof coating and/or a rubber or asphalt embedded material is applied to the exterior foundation wall.

Exterior waterproofing is often combined with installation of perforated drain pipe or “drain tile” being laid in a trench at the base of the foundation wall and surrounded with gravel. This will enable excess water to drain away from the foundation, and is a minimal additional cost to incur once excavation for waterproofing has already been completed. The drain tile can be tied to storm drains or a sump pump to ensure the water is moved away from the foundation.

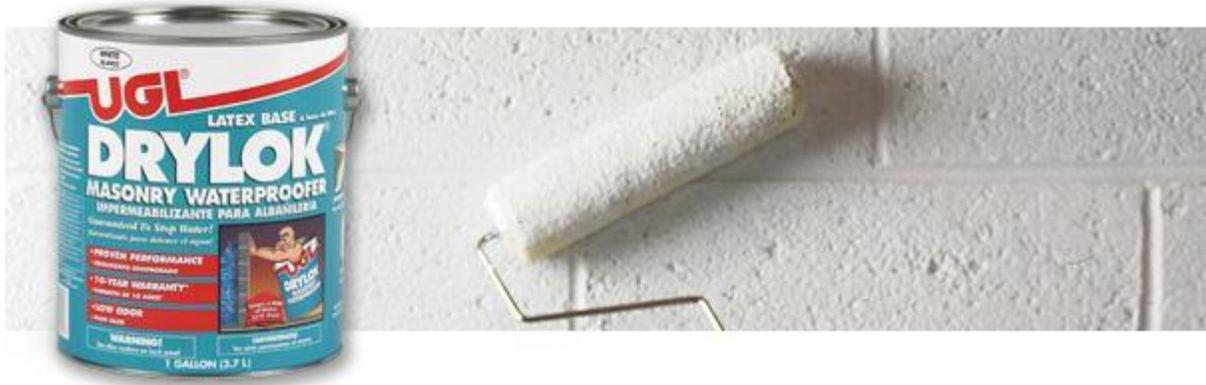
Products such as Drylok, Thoroseal, or Xypex can be used to waterproof foundation walls that are damp (not wet.) These products are applied like a thick paint, and contain either Portland cement or a crystalline material that bond them to the wall.

These products are not effective in areas where water is physically entering through the foundation, and are expected to prevent damp conditions as opposed to stopping active water intrusion into the property.

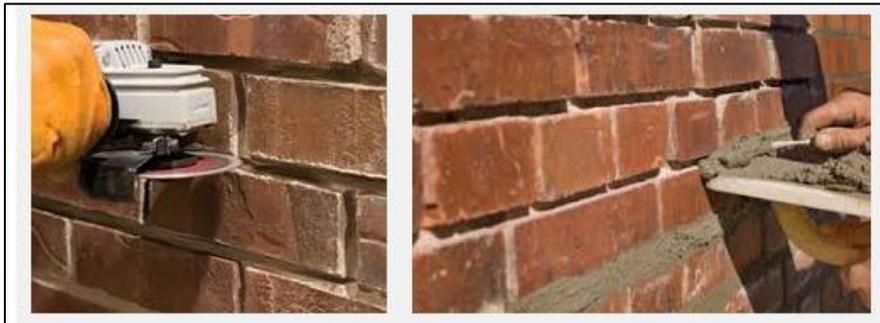
When tuck-pointing, one should take care not to fill in weep holes, which are deliberate gaps in the mortar joints that allow water to pass through. These may be found at the base of a window, allowing any water that found its way in around the edges of the window a path to drain to the exterior. You may also find weep holes at the base of a foundation or retaining wall for the purpose of relieving lateral pressure by letting water pass through the wall.

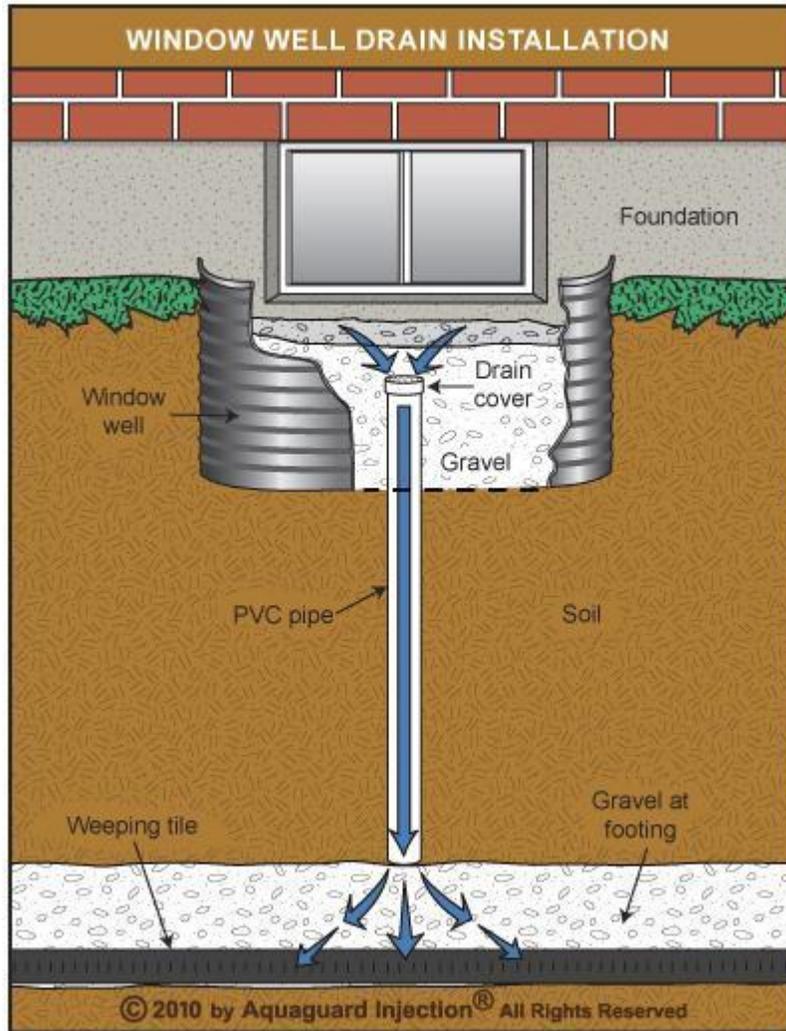
Window wells should contain a drain that connects to a storm sewer, a dry well, or runs out to daylight. If an interior drainage system is being installed, drain tile can be brought through the wall and connected directly to the system. If a drain is not present and there is seepage around the window, a drain should be installed. If a drain is present, it should be inspected to ensure it is not clogged. In any case, a cover should additionally be installed over the window well to keep debris like grass clippings or leaves from clogging the drain.

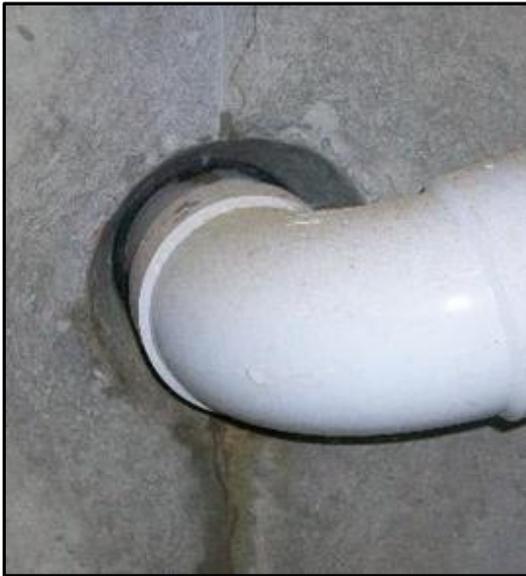
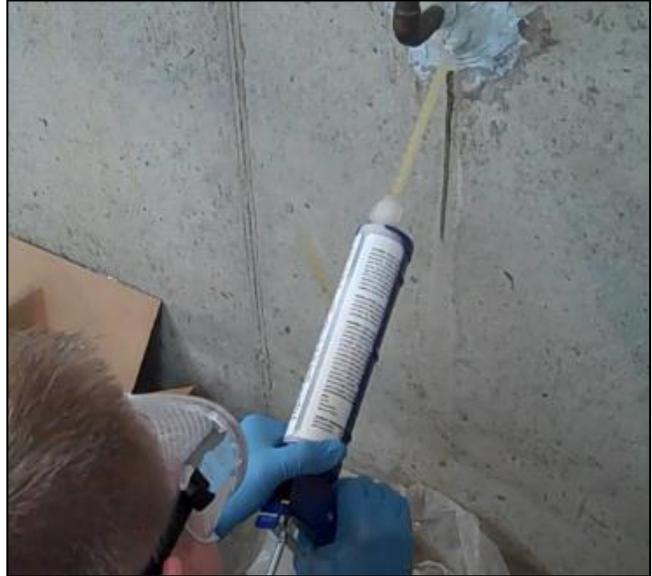
Any prior patching should be removed to expose the gap around the pipe in the foundation wall. A series of small plastic ports are placed around the pipe and held in place with a non-shrink waterproof mortar. After the surface patch has dried an epoxy/urethane resin is injected to fill the void. These can be addressed from the exterior as well.

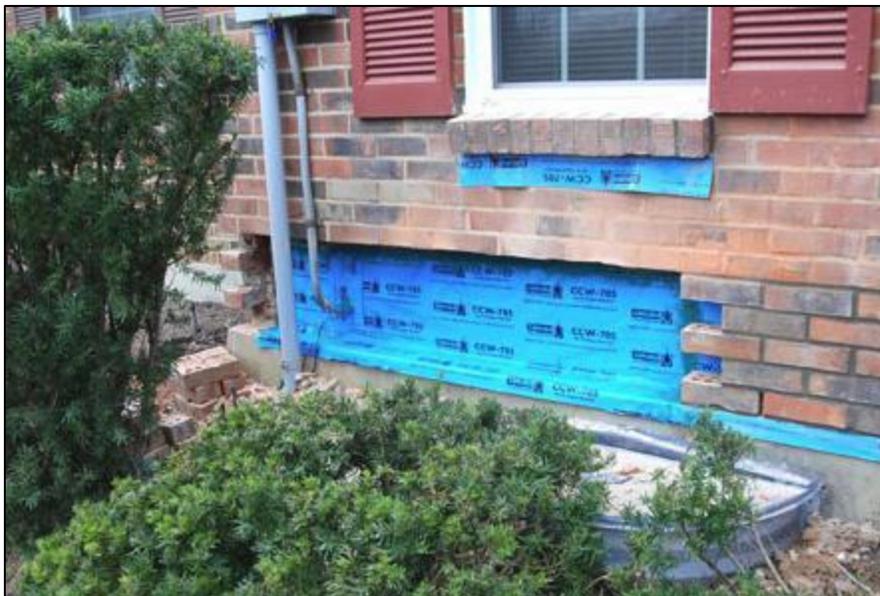
Brick walls leak by nature, and thru-the-wall flashing will catch the water and divert it out the weep holes to the exterior of the home. If this flashing is missing or damaged, the only way to repair is removing the brick veneer at the base of the exterior wall and installing new flashing behind the brick. This will allow water to drain away from the home to the exterior.

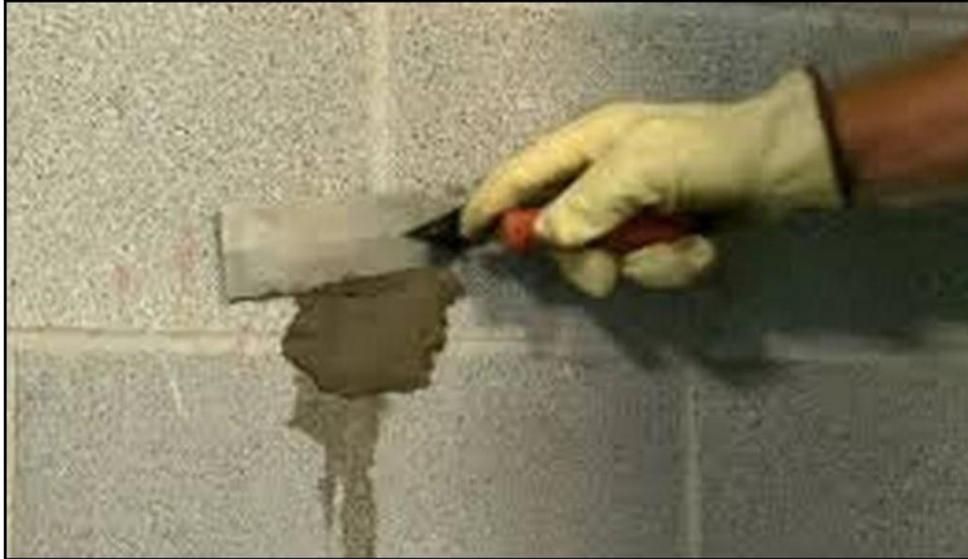
A water plug is a cement patch that has additives to decrease the amount of setting time, and prevent the mix from shrinking like normal cement. This type of repair should be made from the exterior, and sealed with tar or a waterproofing membrane.
